2023 CCWMO Project Review

WMOAC MEETING

SEPTEMBER 26, 2023

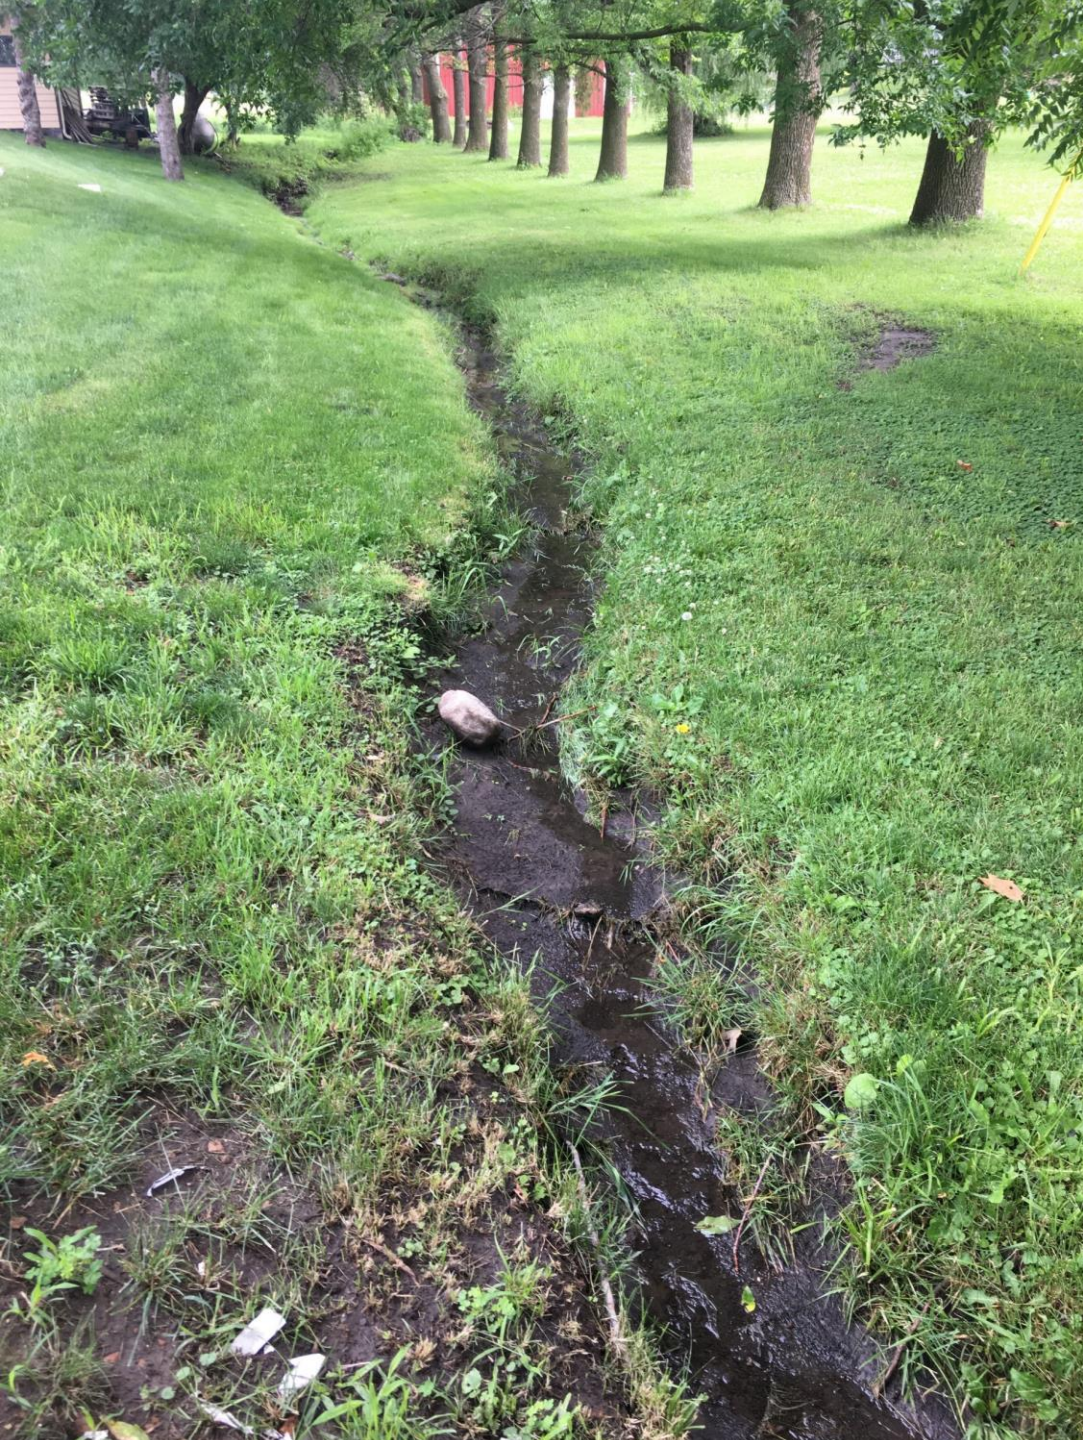
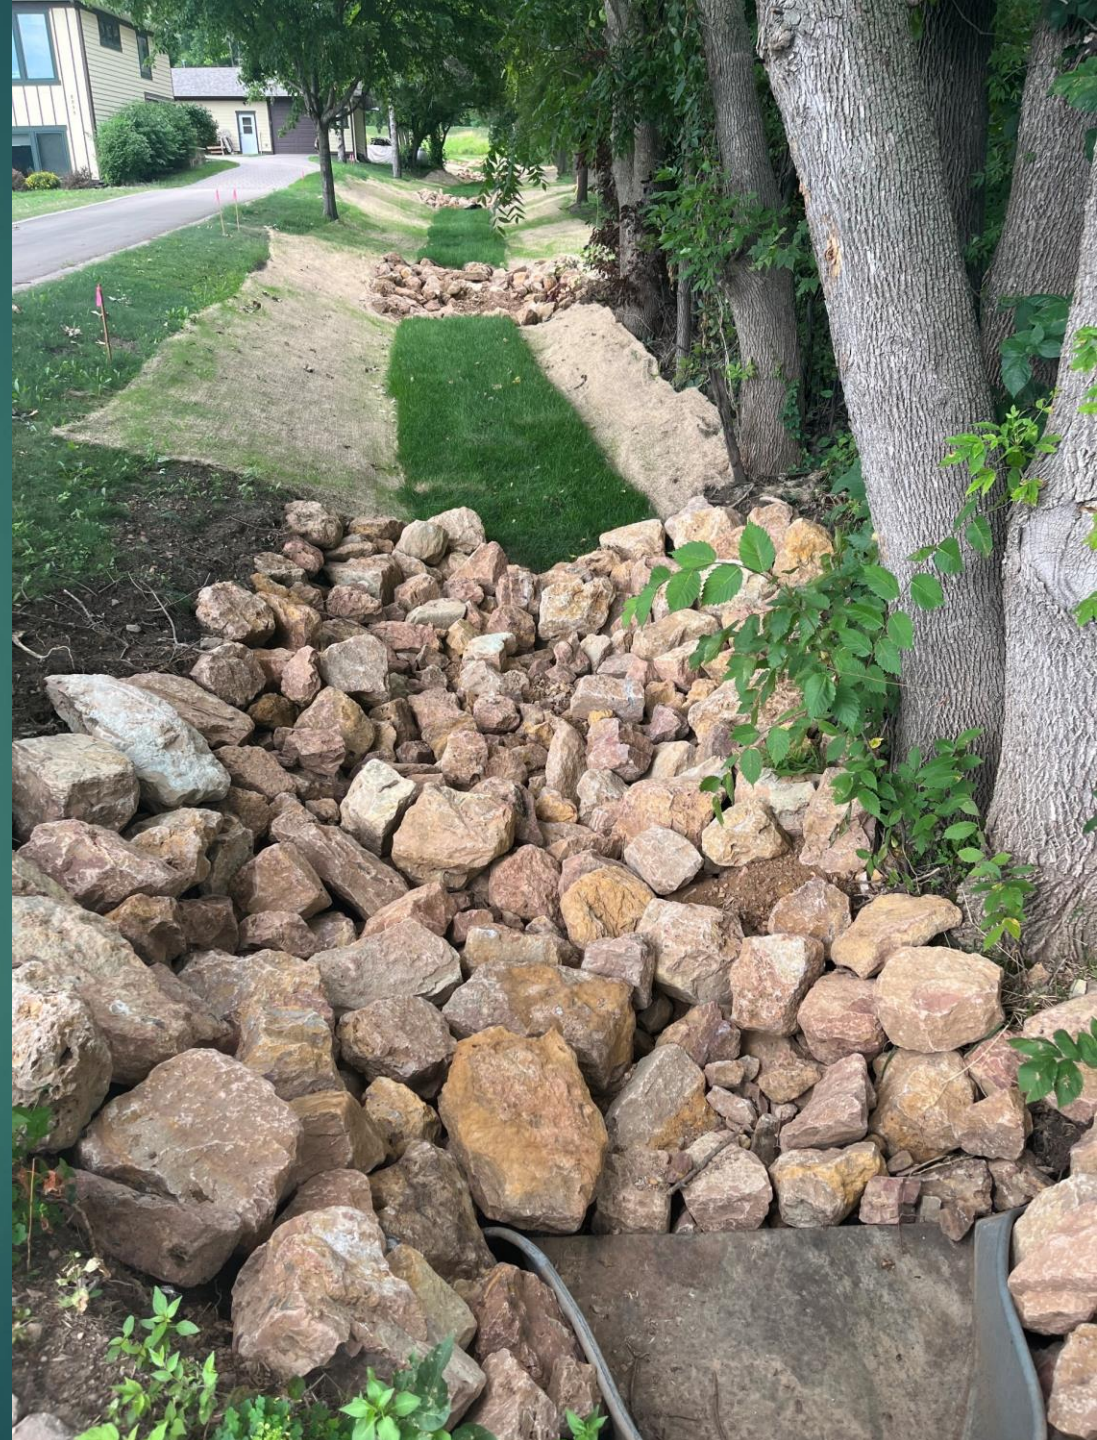
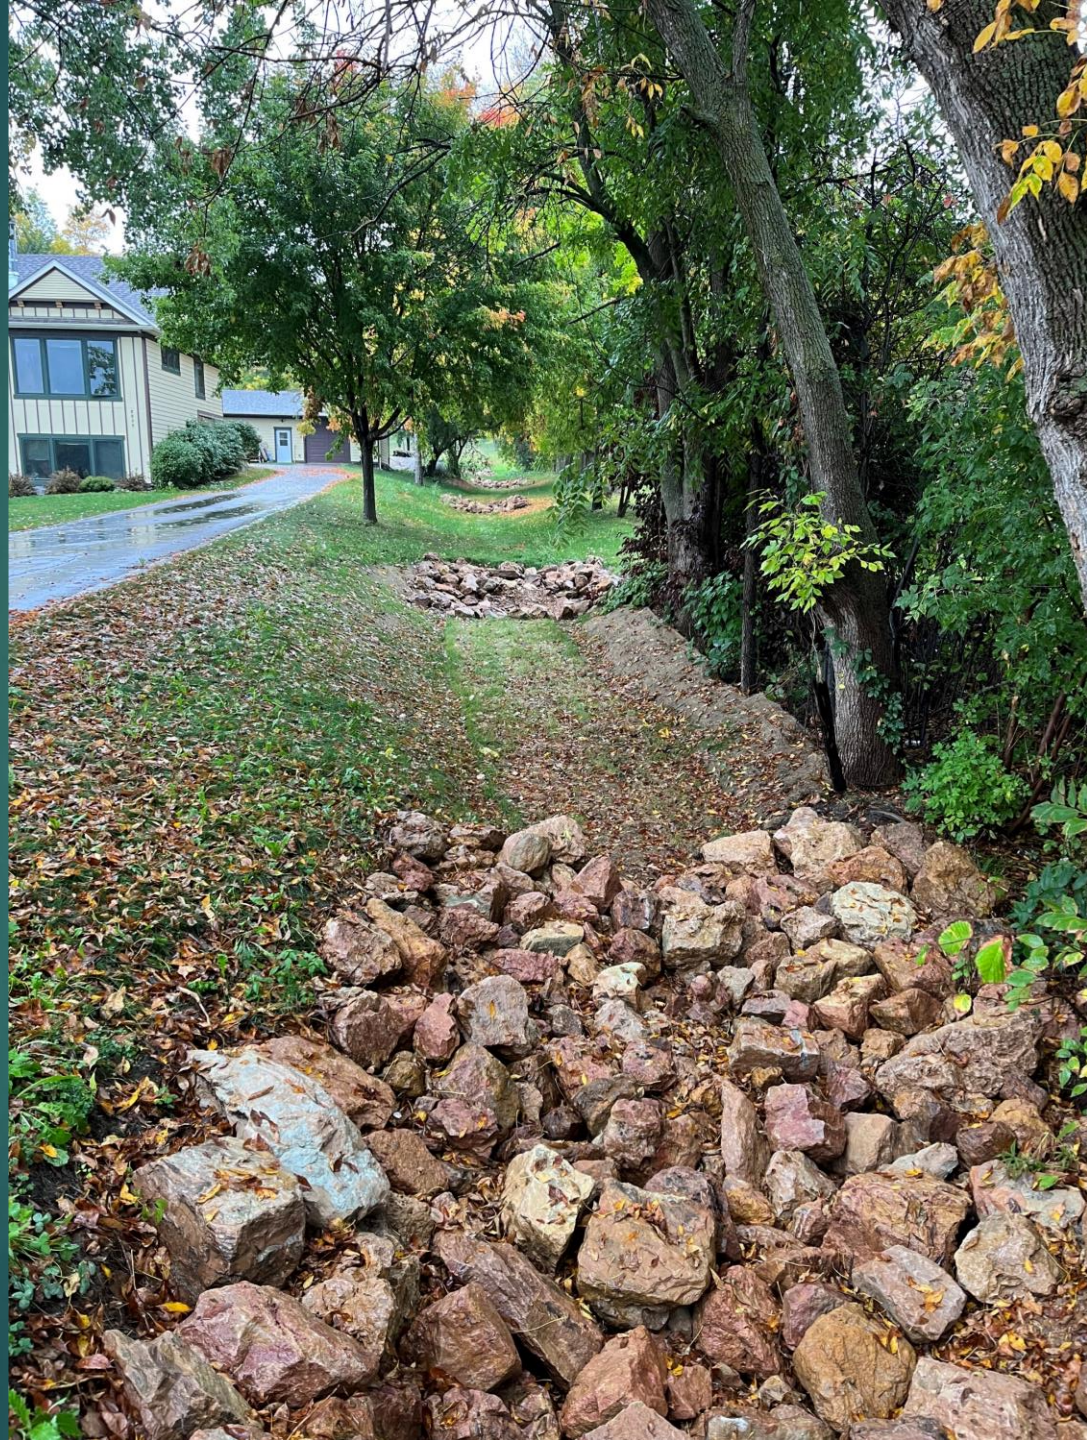
Reitz Lake Ravine Project

- ▶ A ravine formed through a private resident's property from Airport Road down to Reitz Lake Road. A plan set was developed in 2021 to stabilize the ravine.
- ▶ Received a \$40,000 BWSR Grant to construct the project. Total project costs was \$48,298.80

- ▶ This project was completed in July.

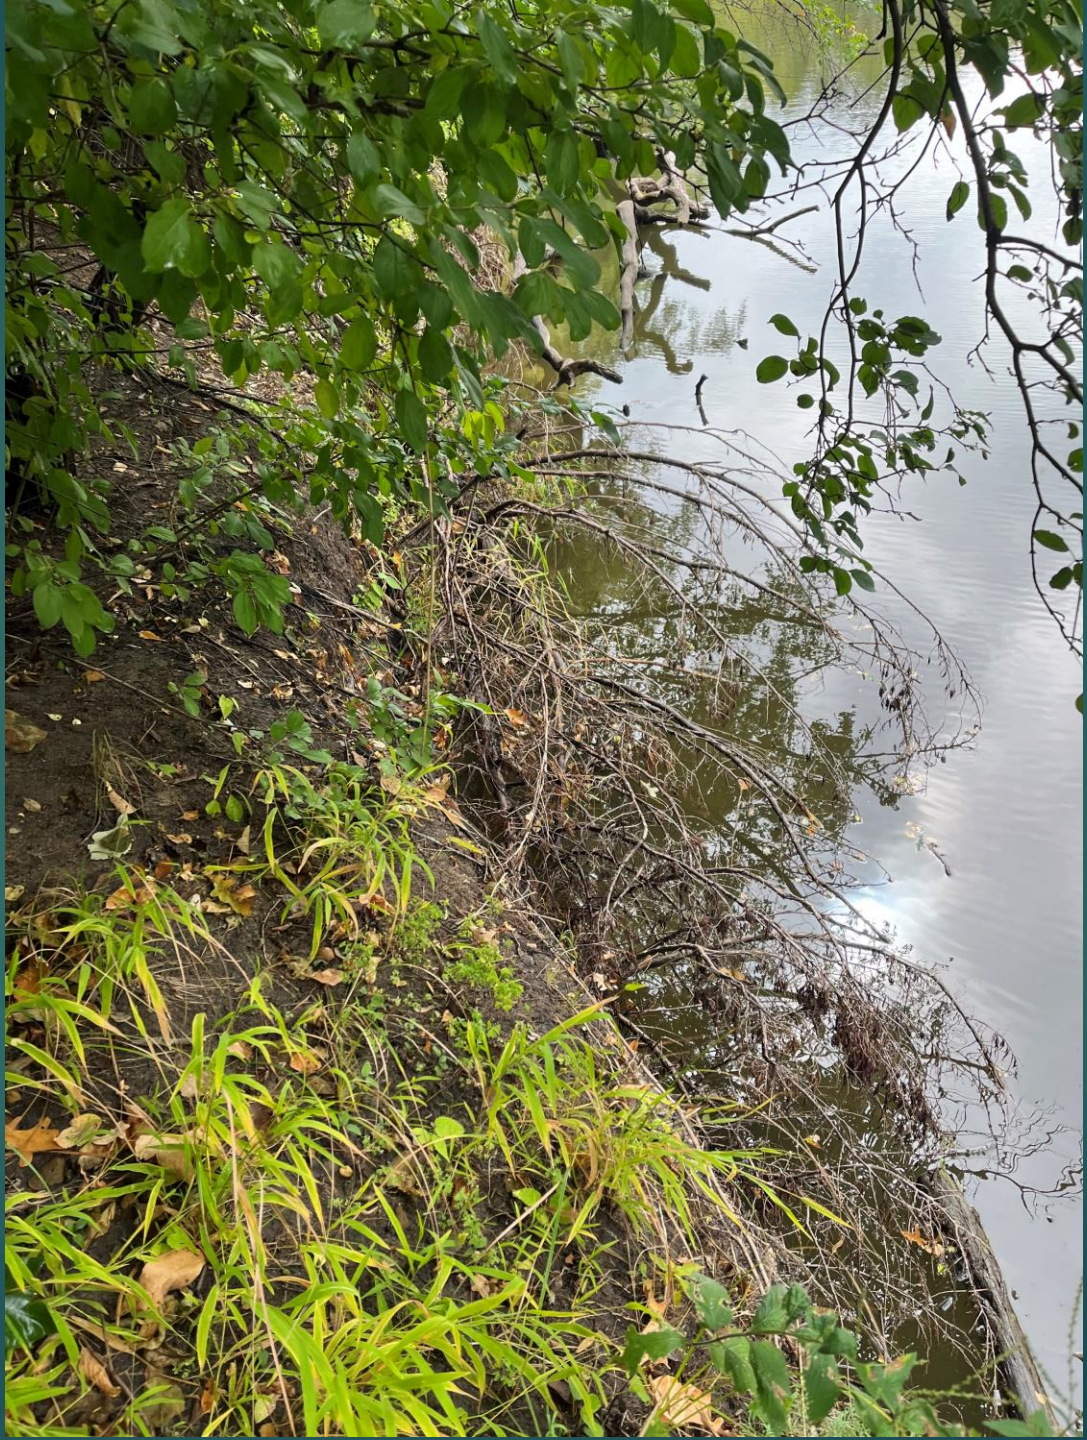
- ▶ Site inspections were completed in the spring and fall to assess how the site responded. Mortality rate of live stakes are roughly 40%, which is around what was estimated. The cedar revetments are still holding and have sediment deposition on them.

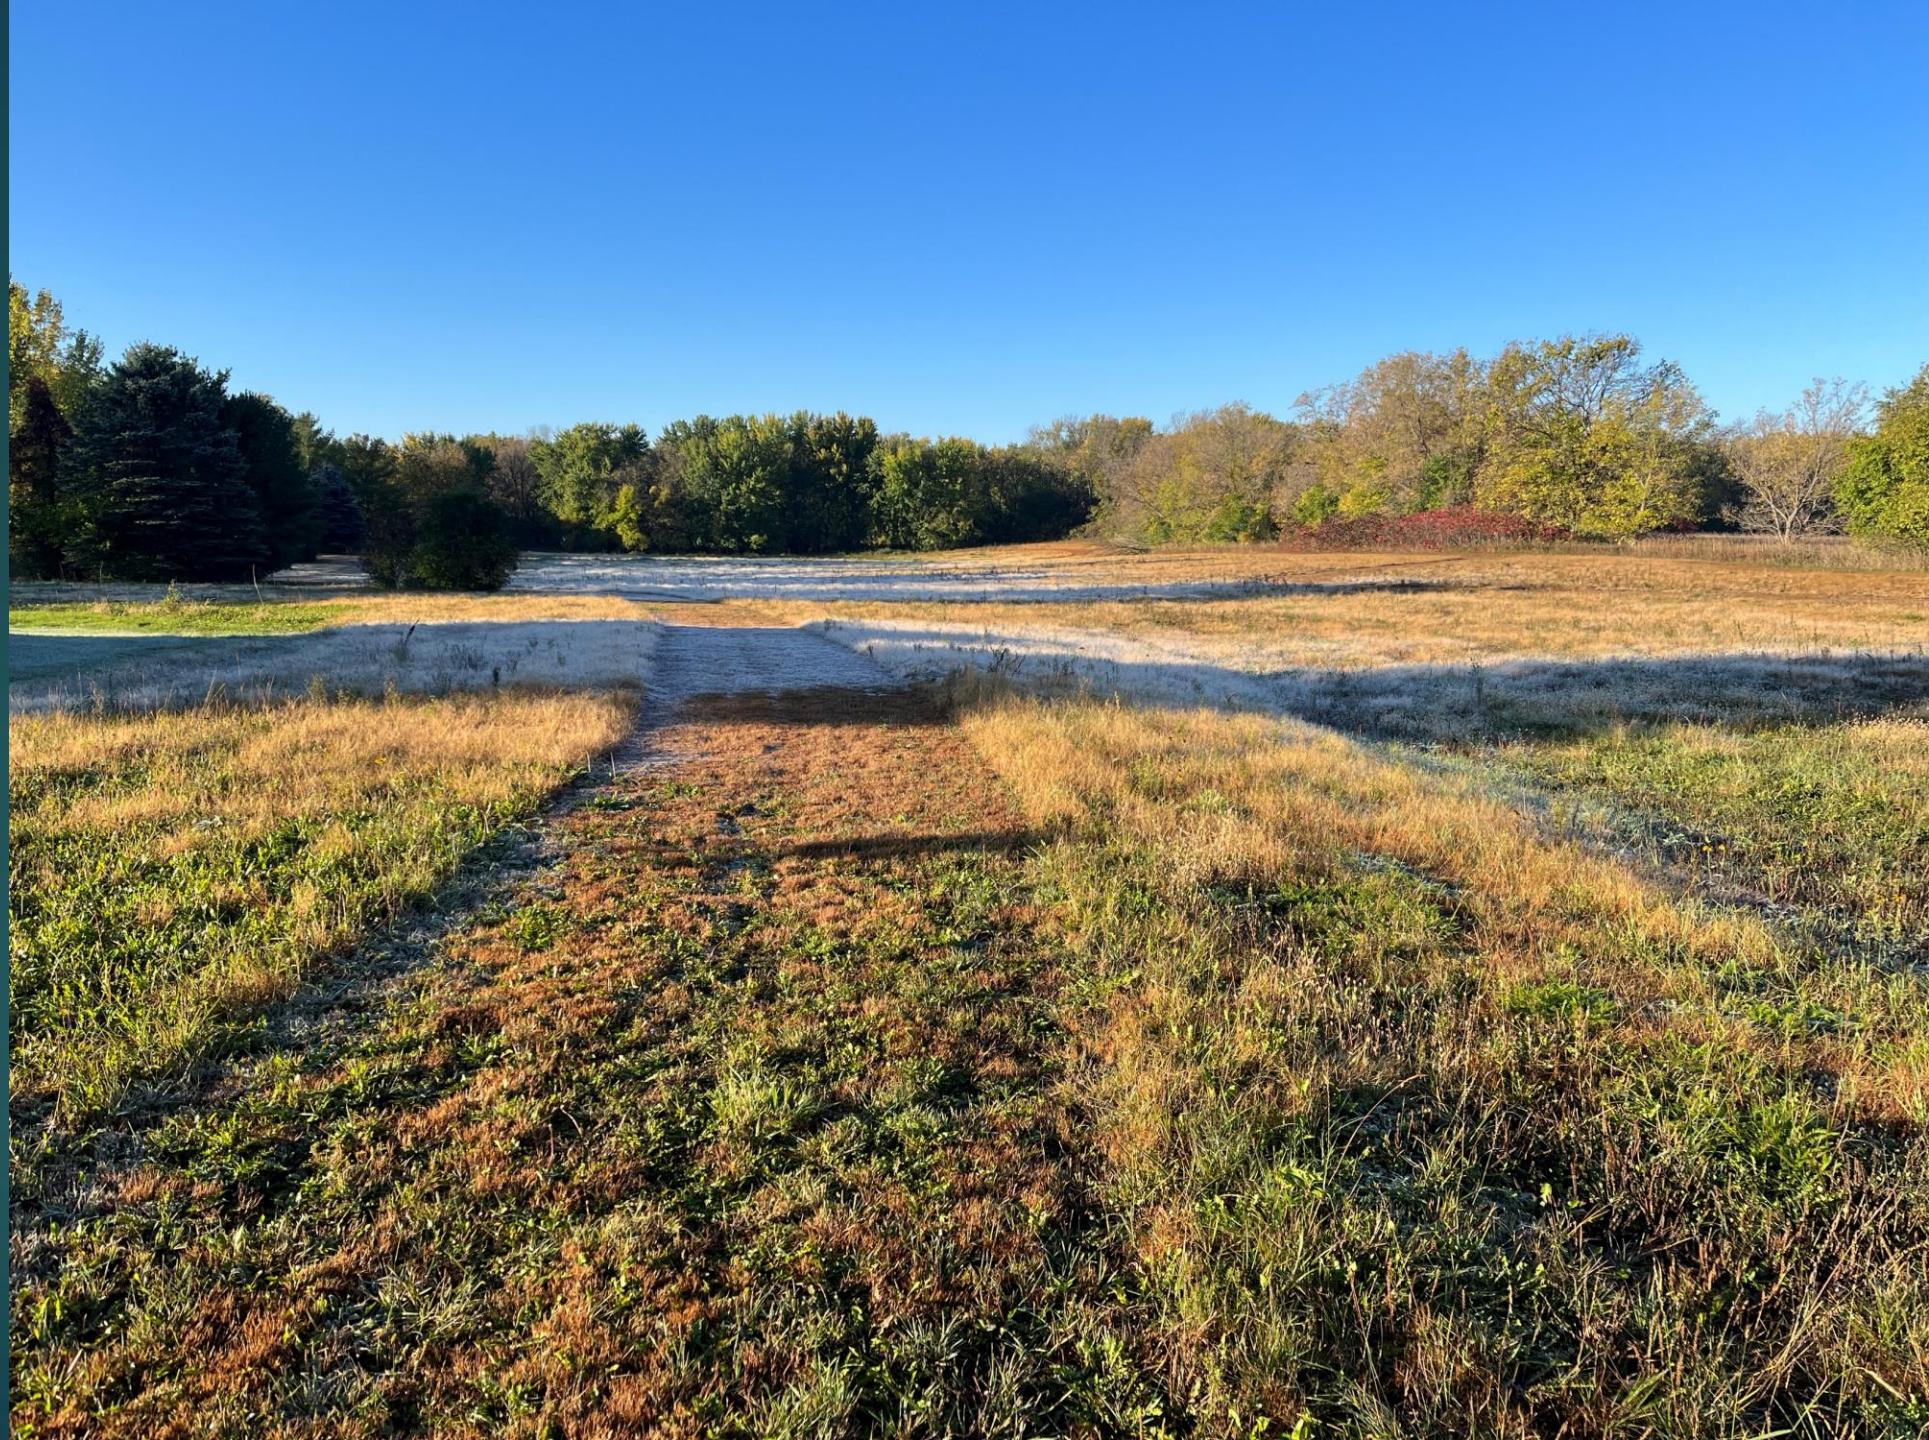
Watertown Turf to Native Sites

- ▶ Three sites, totaling 9.6 acres, have undergone native prairie restoration in Watertown. This is the final year of a three-year grant, with the City of Watertown taking over maintenance of the sites to ensure that these areas are fully established.
- ▶ Received a \$40,000 grant from BWSR to complete this project. Total costs are \$54,000

- ▶ Final year of the grant. This has been a tough three year stretch to establish a prairie through seeding and plugs.
- ▶ Work with the city to ensure that these sites become established

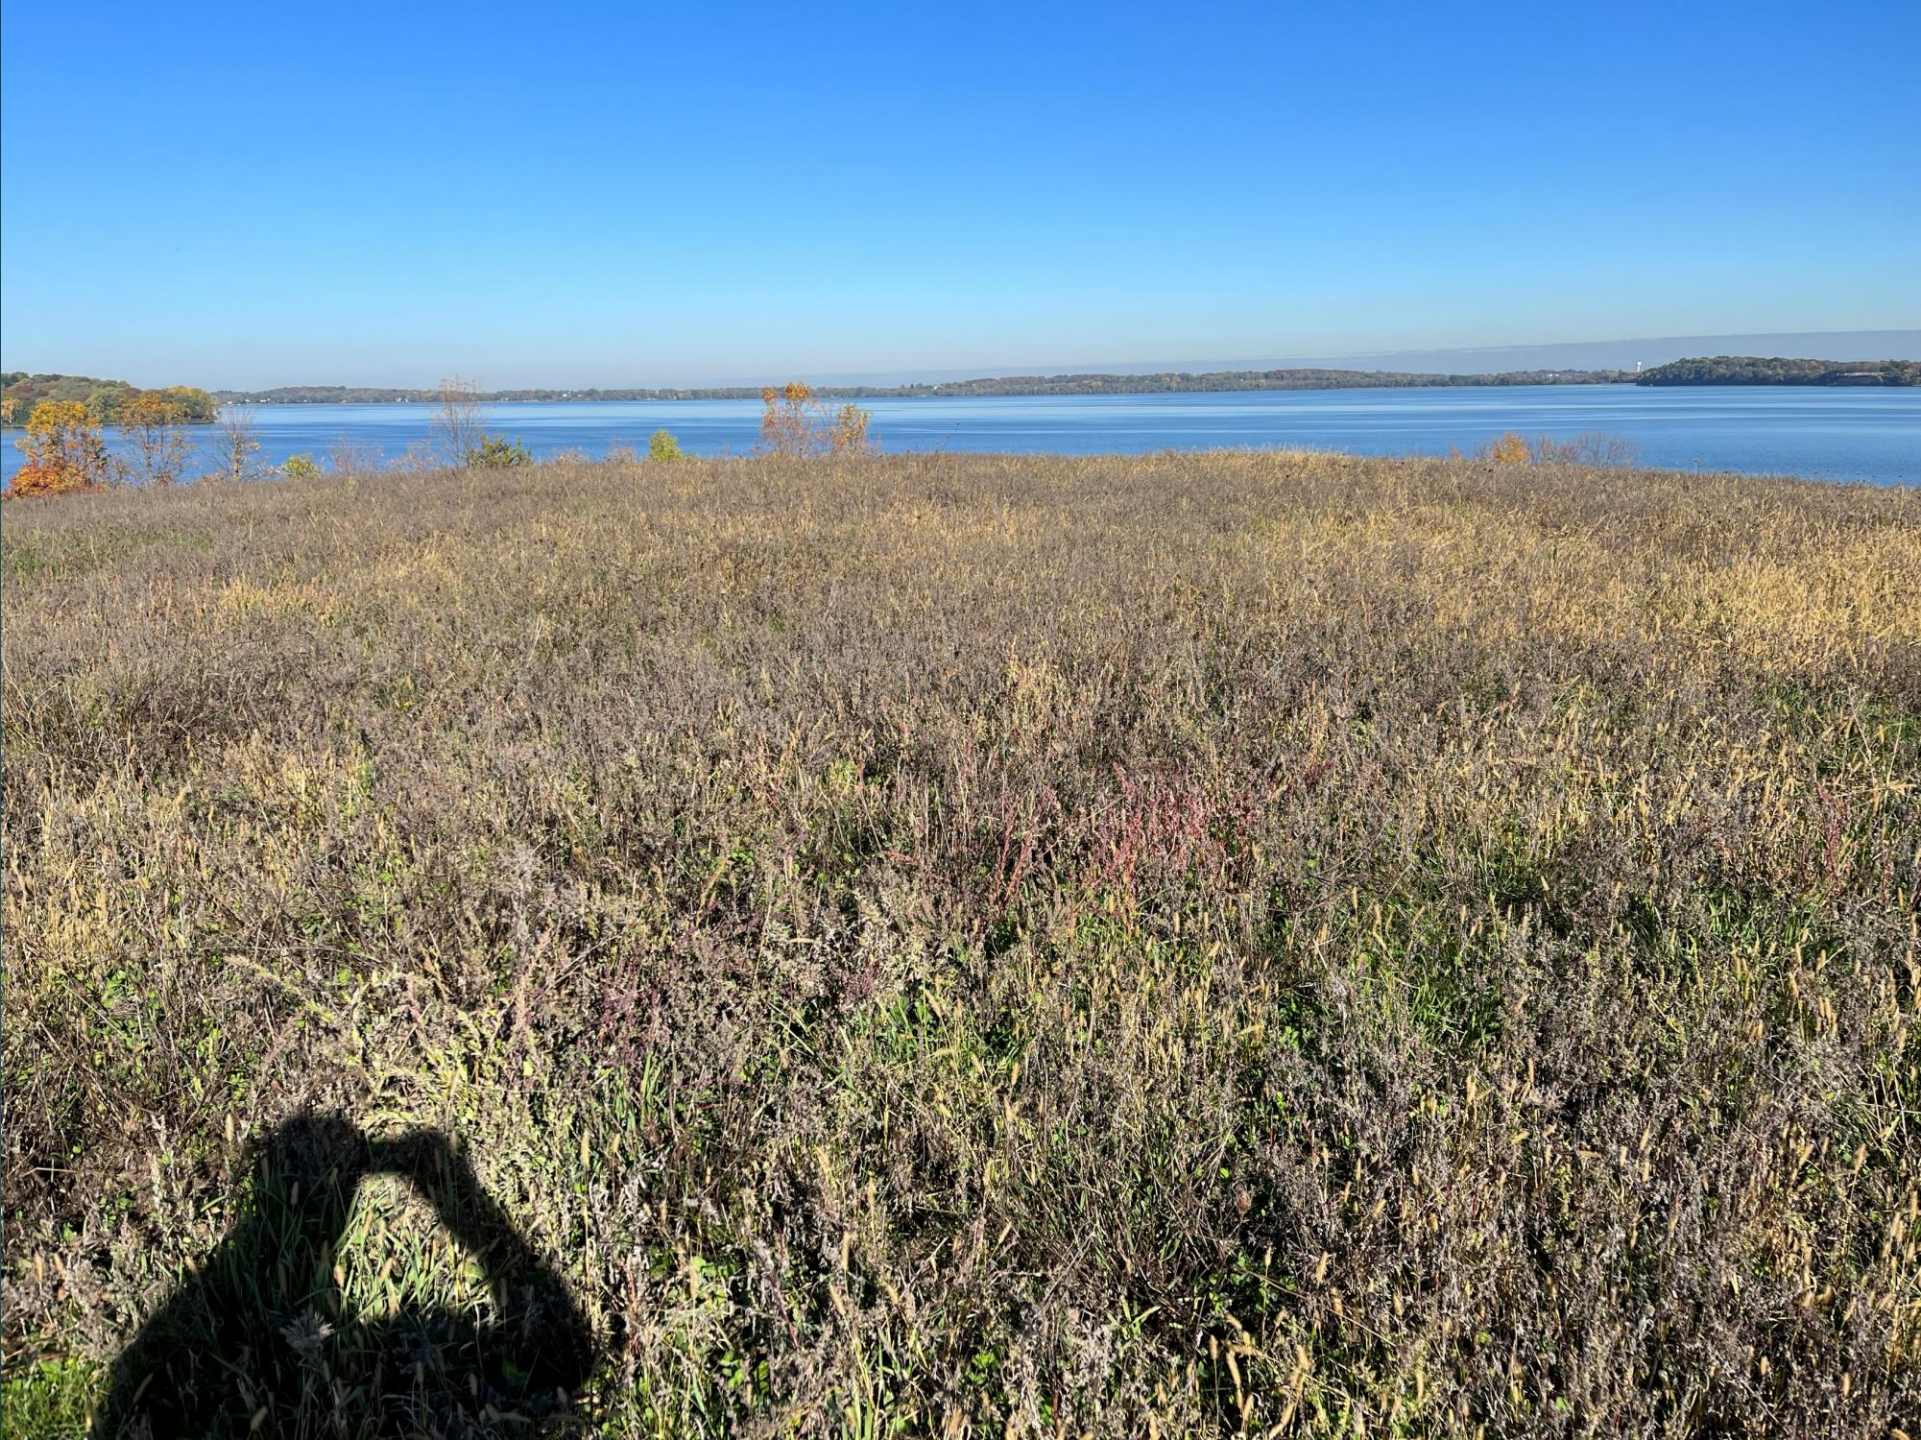
Waconia Turf to Native Sites

- ▶ Four sites, totaling 10.6 acres, have undergone a native prairie restoration in and around Waconia. Granted an extension due to staff turnover at management company, will end June 30th, 2024. The city will maintain three sites, and Carver County Parks will maintain the final site
- ▶ Received \$40,000 from a BWSR Grant. Total costs are estimated to be \$52,000.

- ▶ Each site had three visits from Prairie Restoration Inc to assess the status of the site, remove annual weeds, and decide if further work was necessary.
- ▶ These sites will be turned over to Carver County Parks and the City of Waconia at the end of June, 2024.

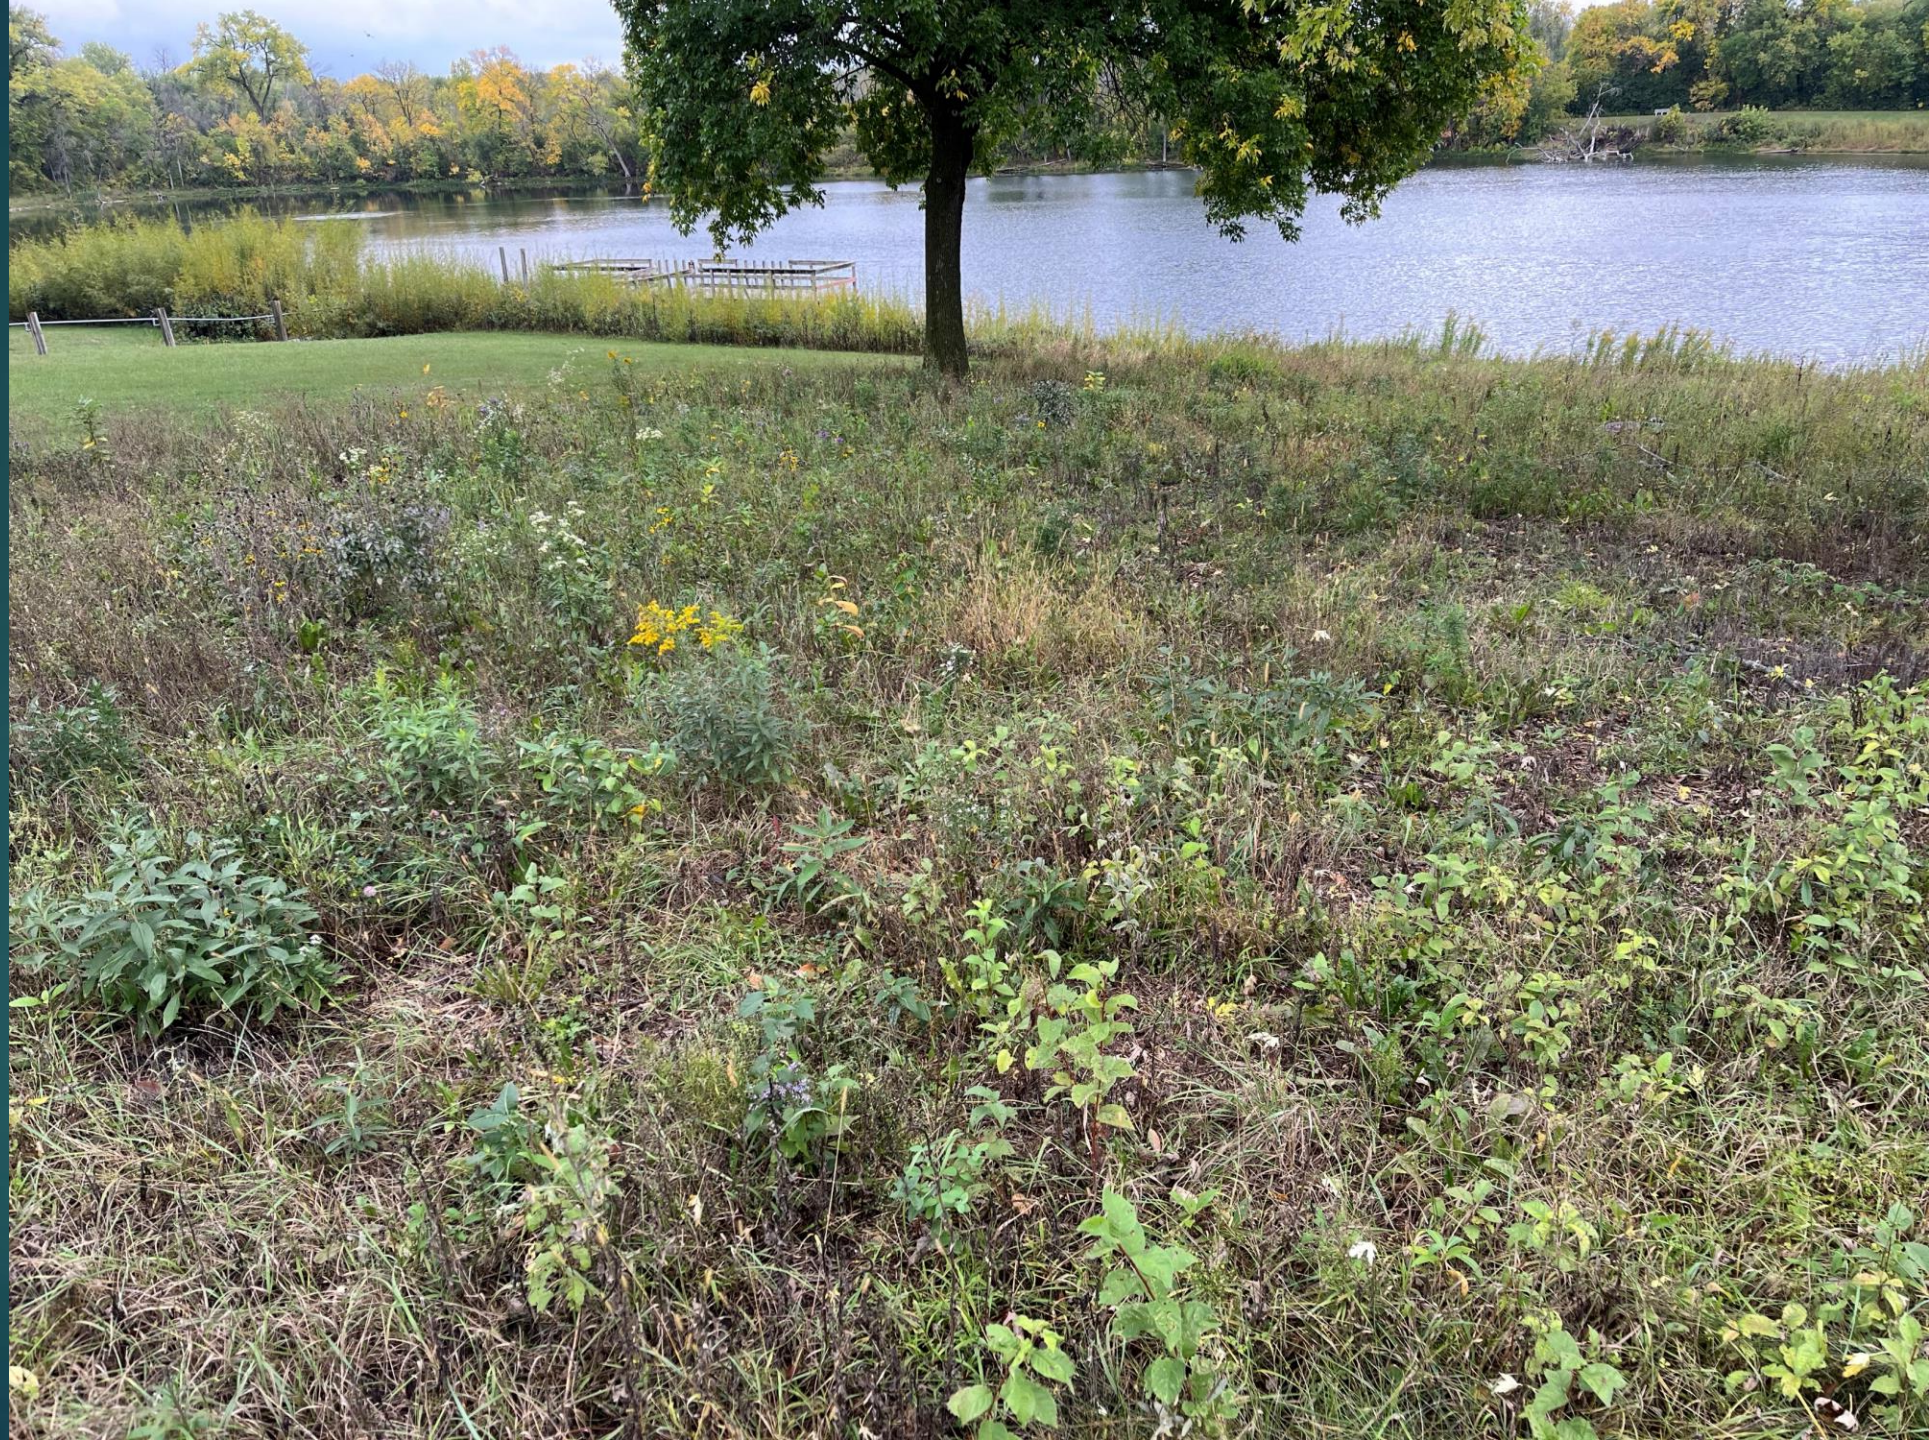
Courthouse Buffer Project

- ▶ 2.5 acres around Courthouse Lake were transitioned from maintained turf grass to native vegetation.
- ▶ Received \$12,430 from a DNR Grant. Total costs are \$13,211.27.

- ▶ Final plantings and seeding was completed in June, with a June 30th deadline for the grant.
- ▶ Currently, CCWMO and SWCD is maintaining these sites.
