2023 CCWMO Project Review

WMOAC MEETING

SEPTEMBER 26, 2023

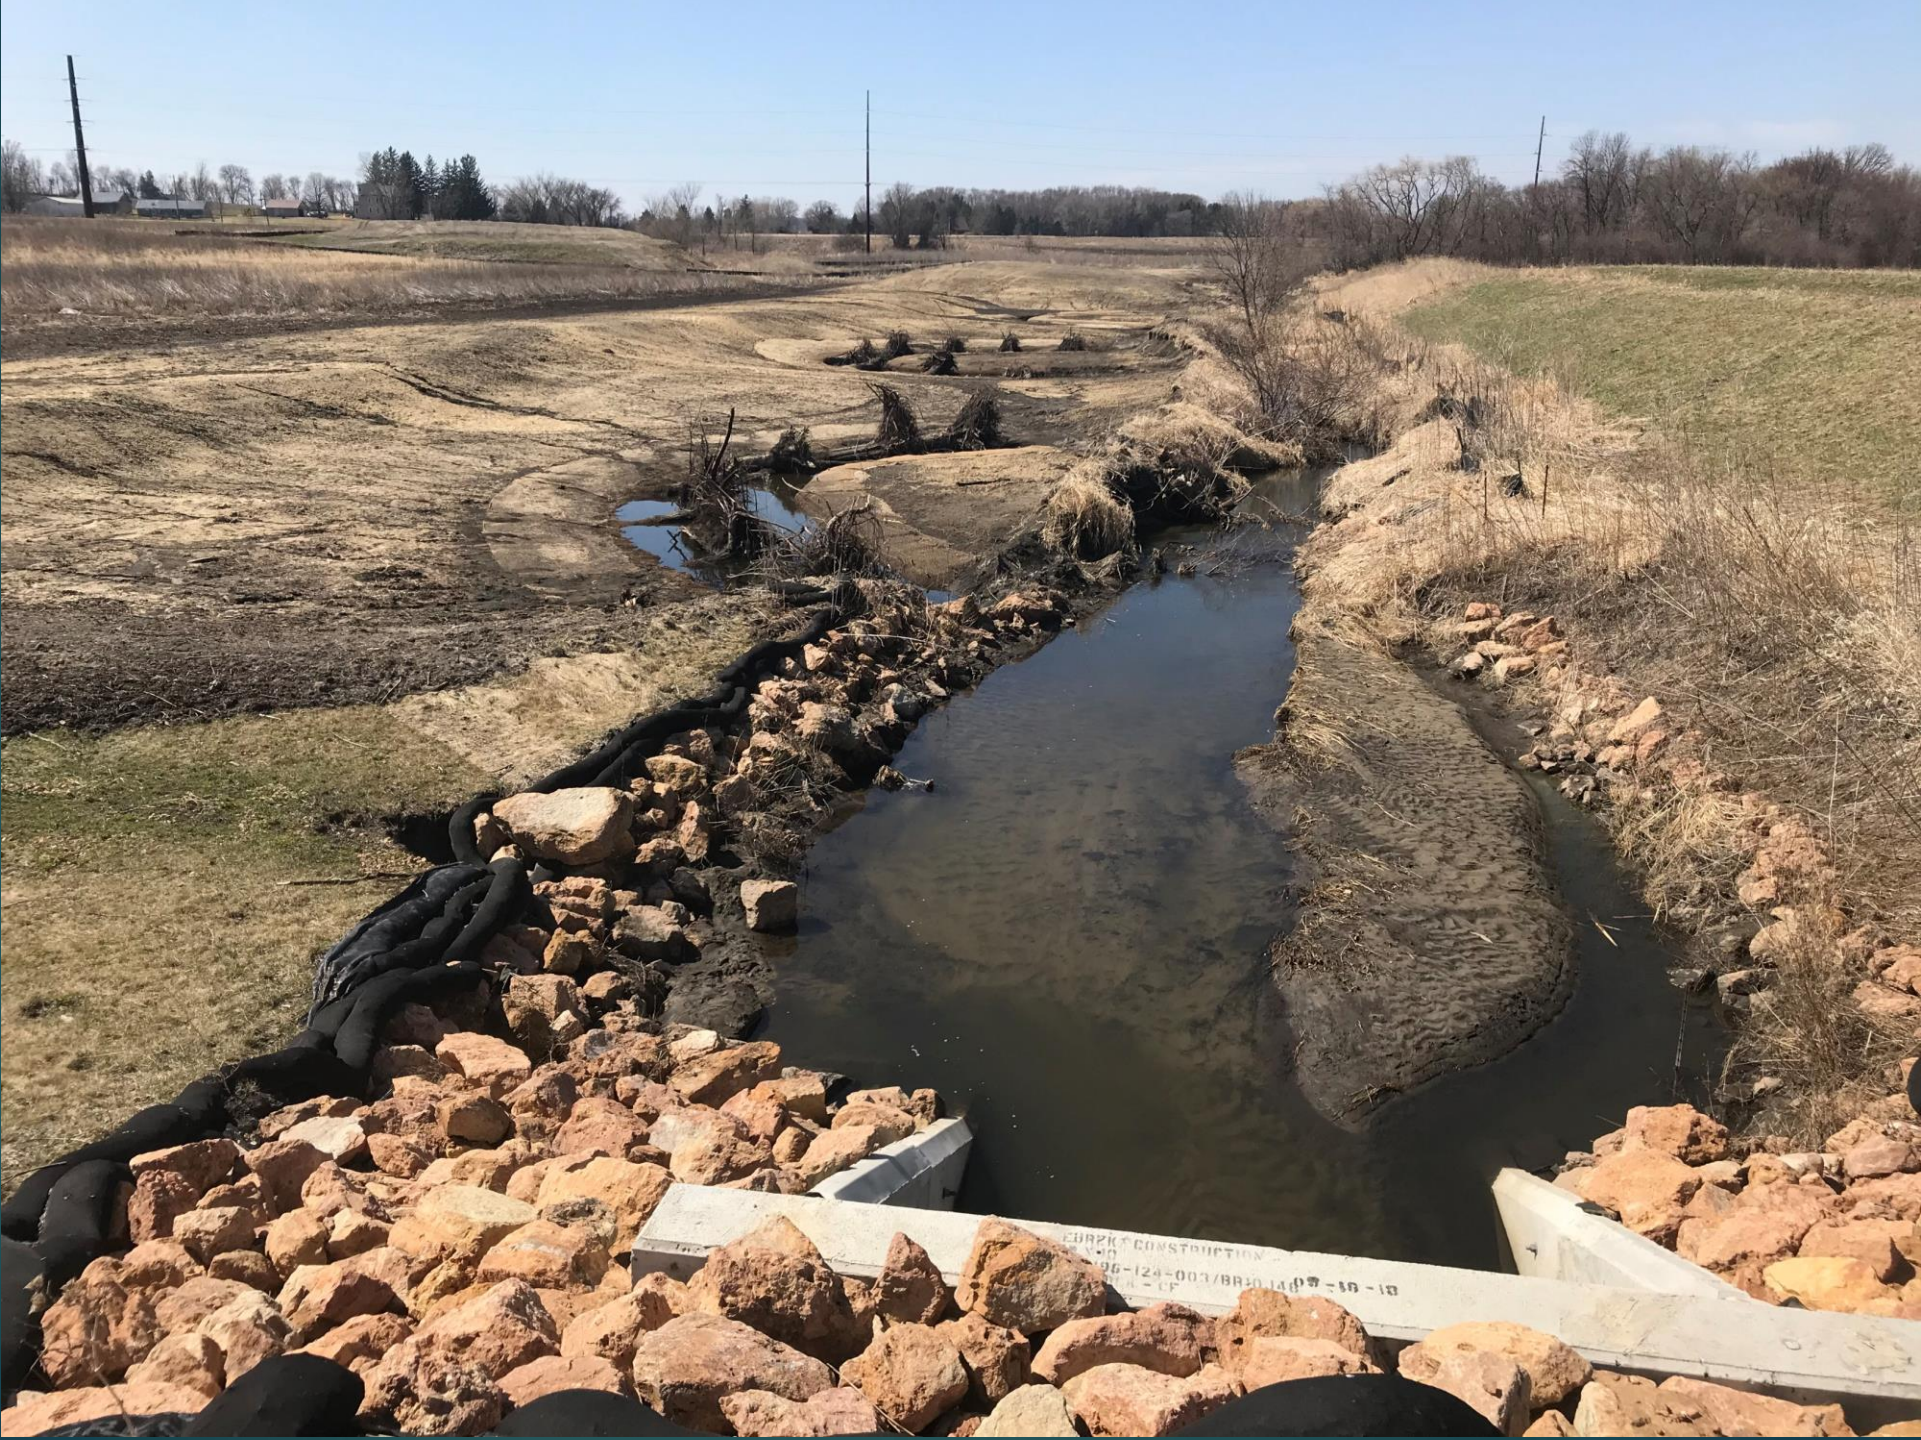
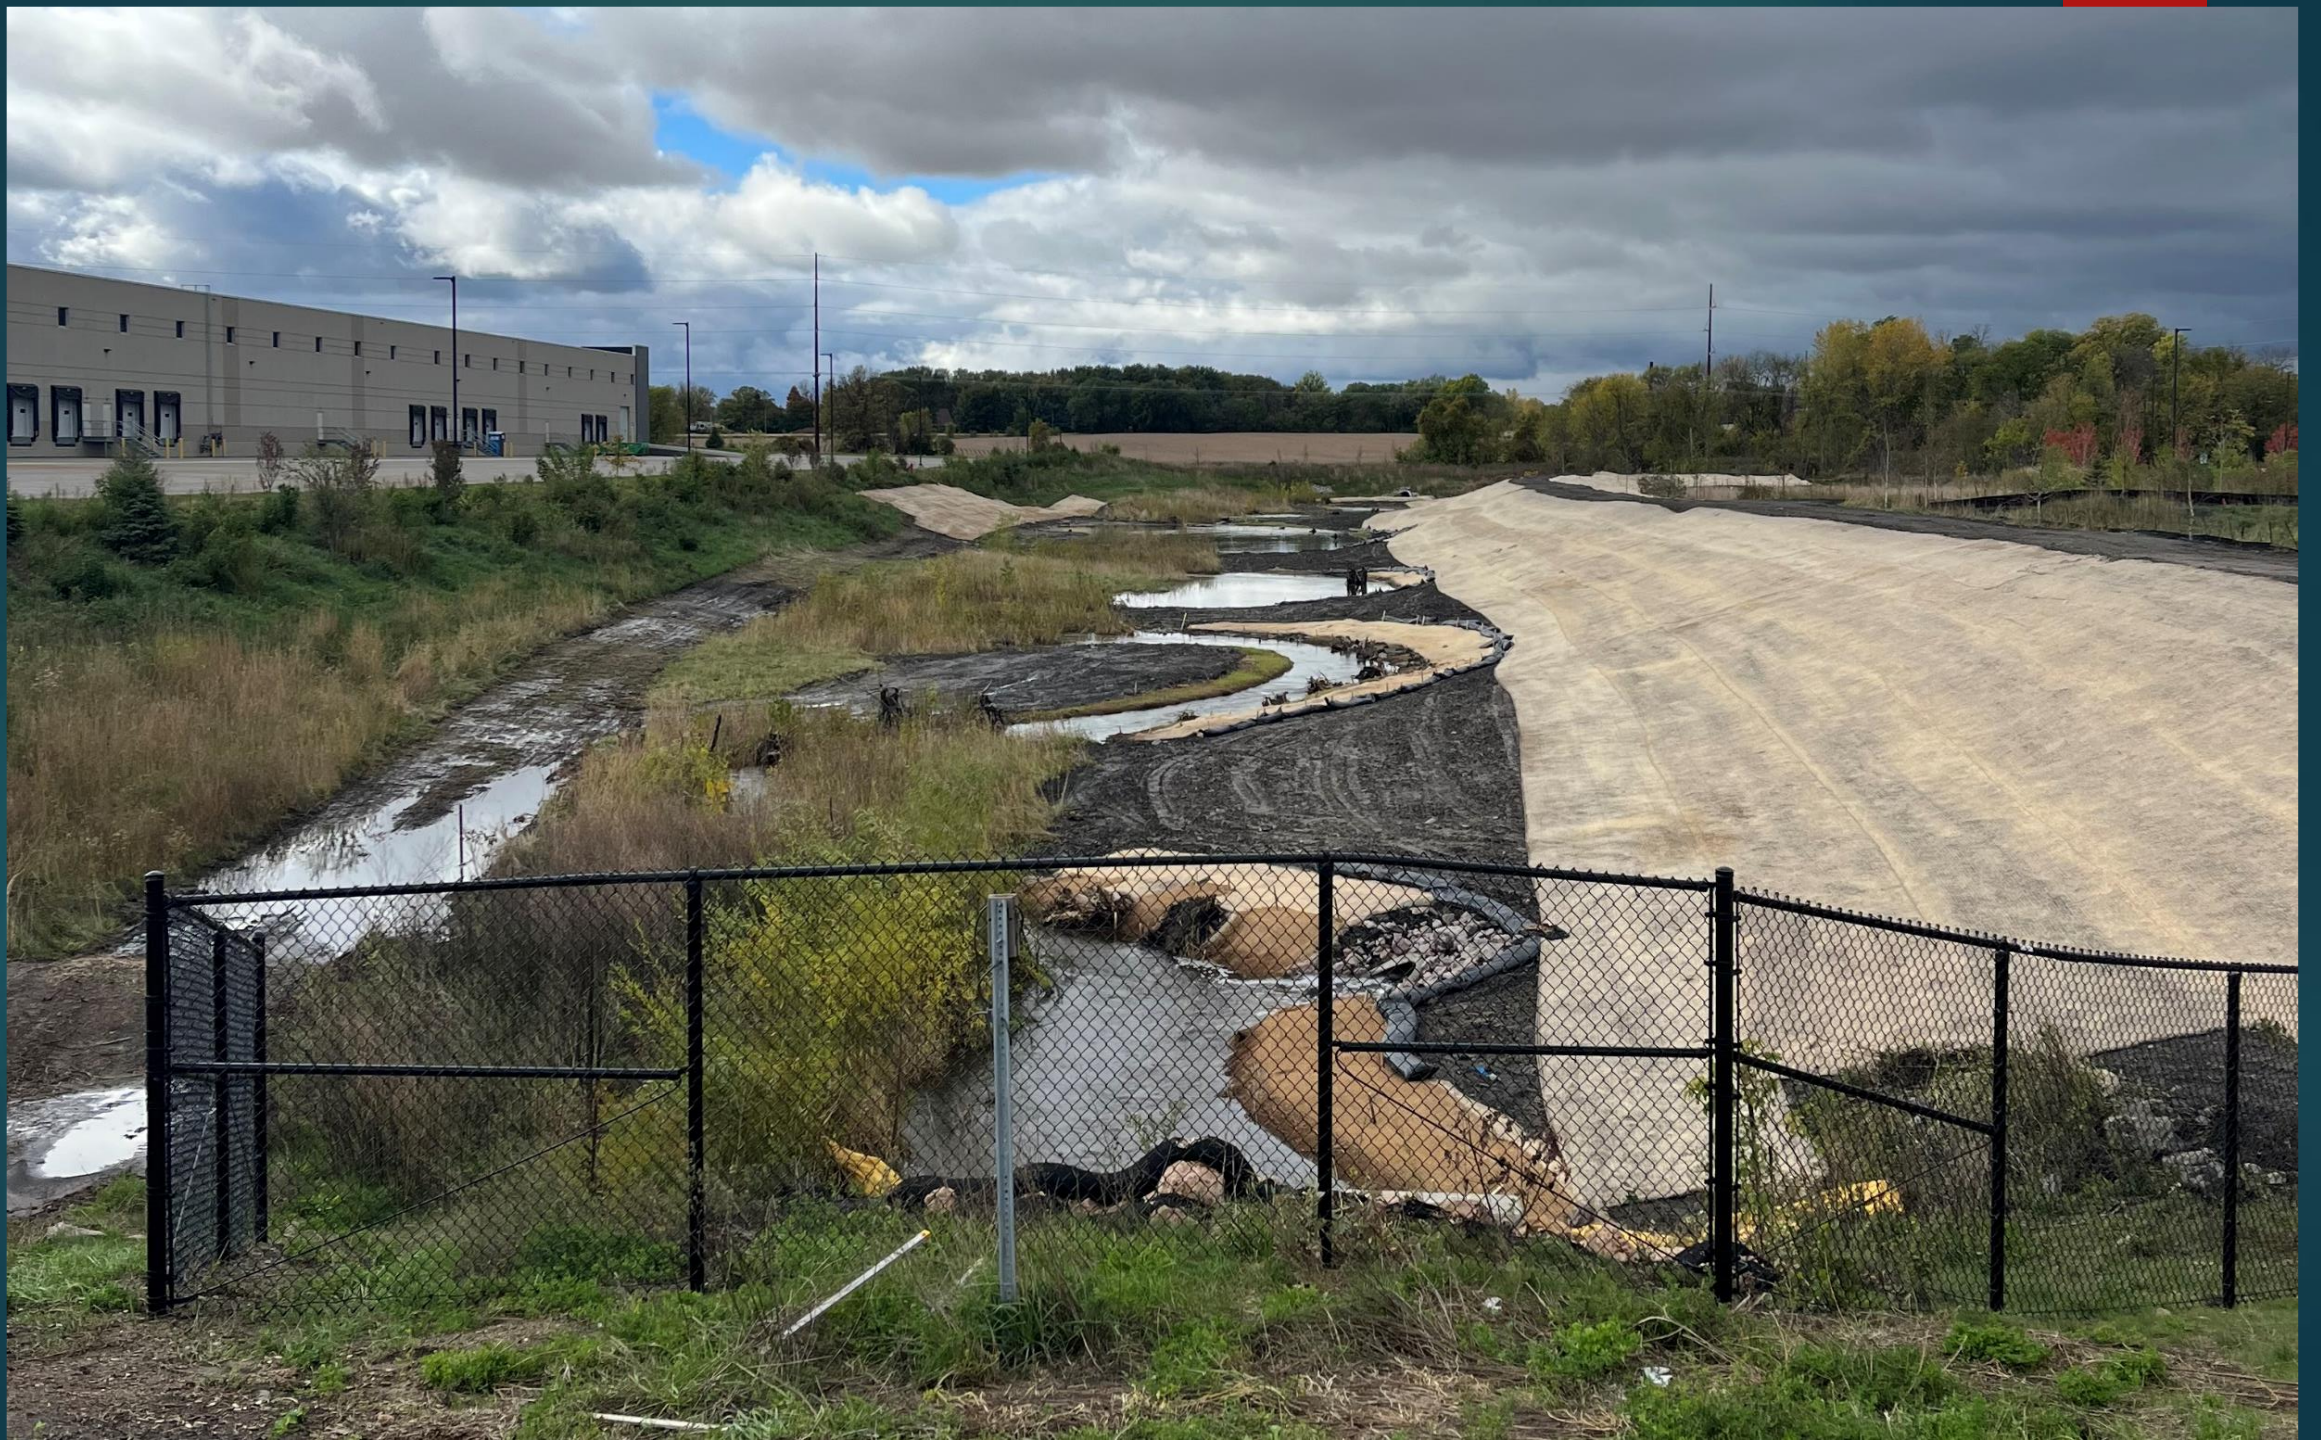
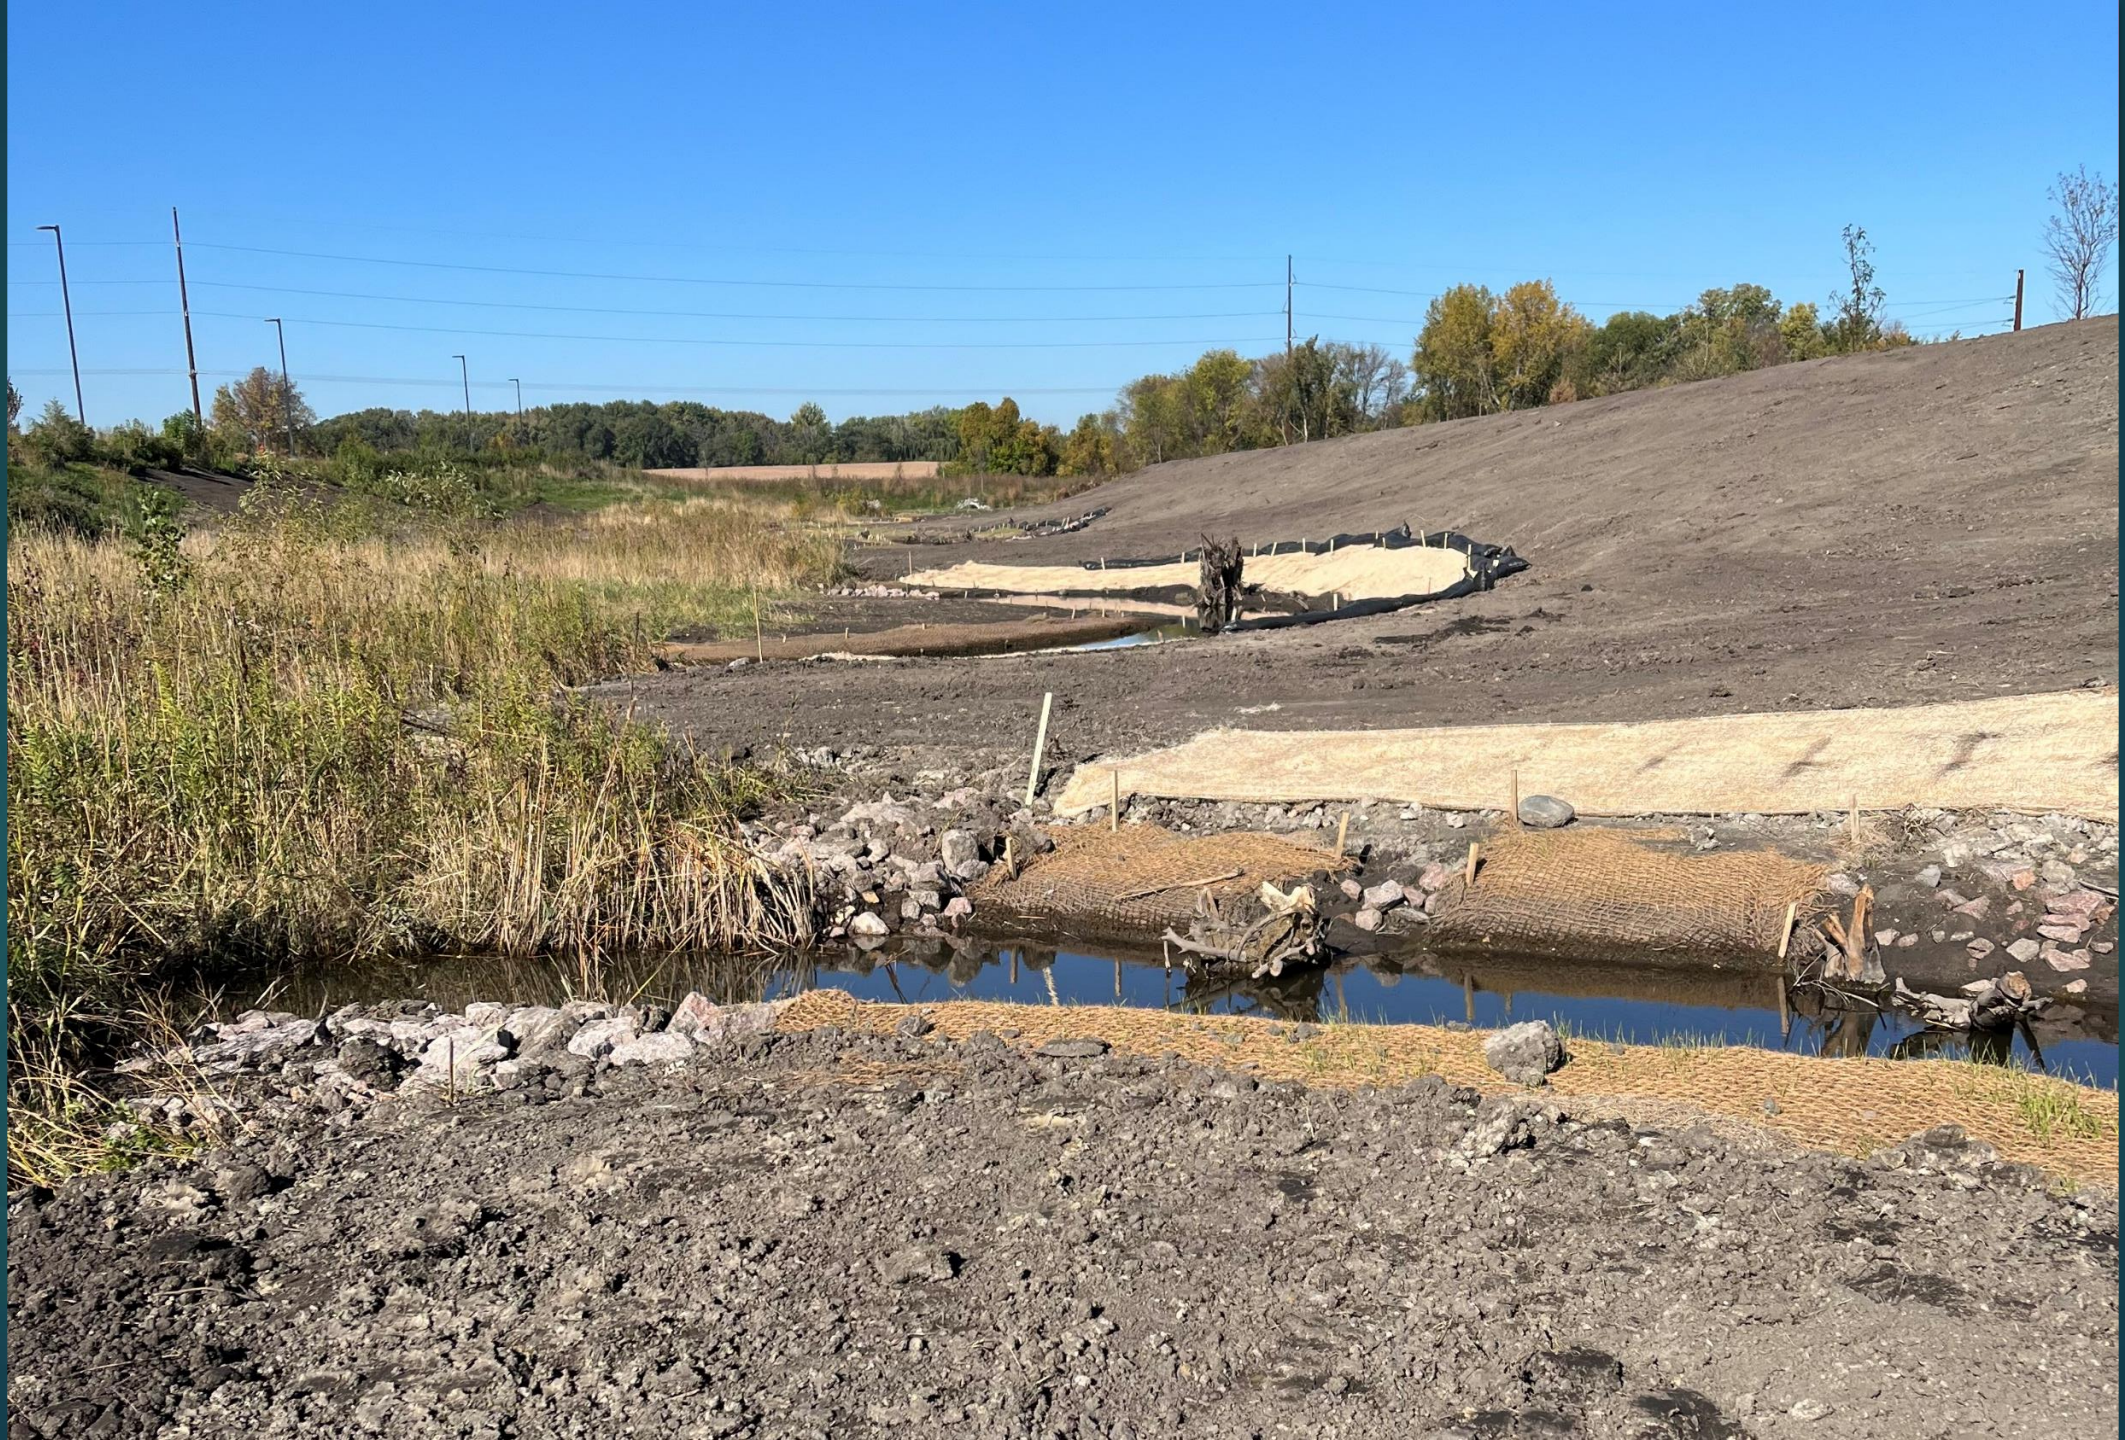
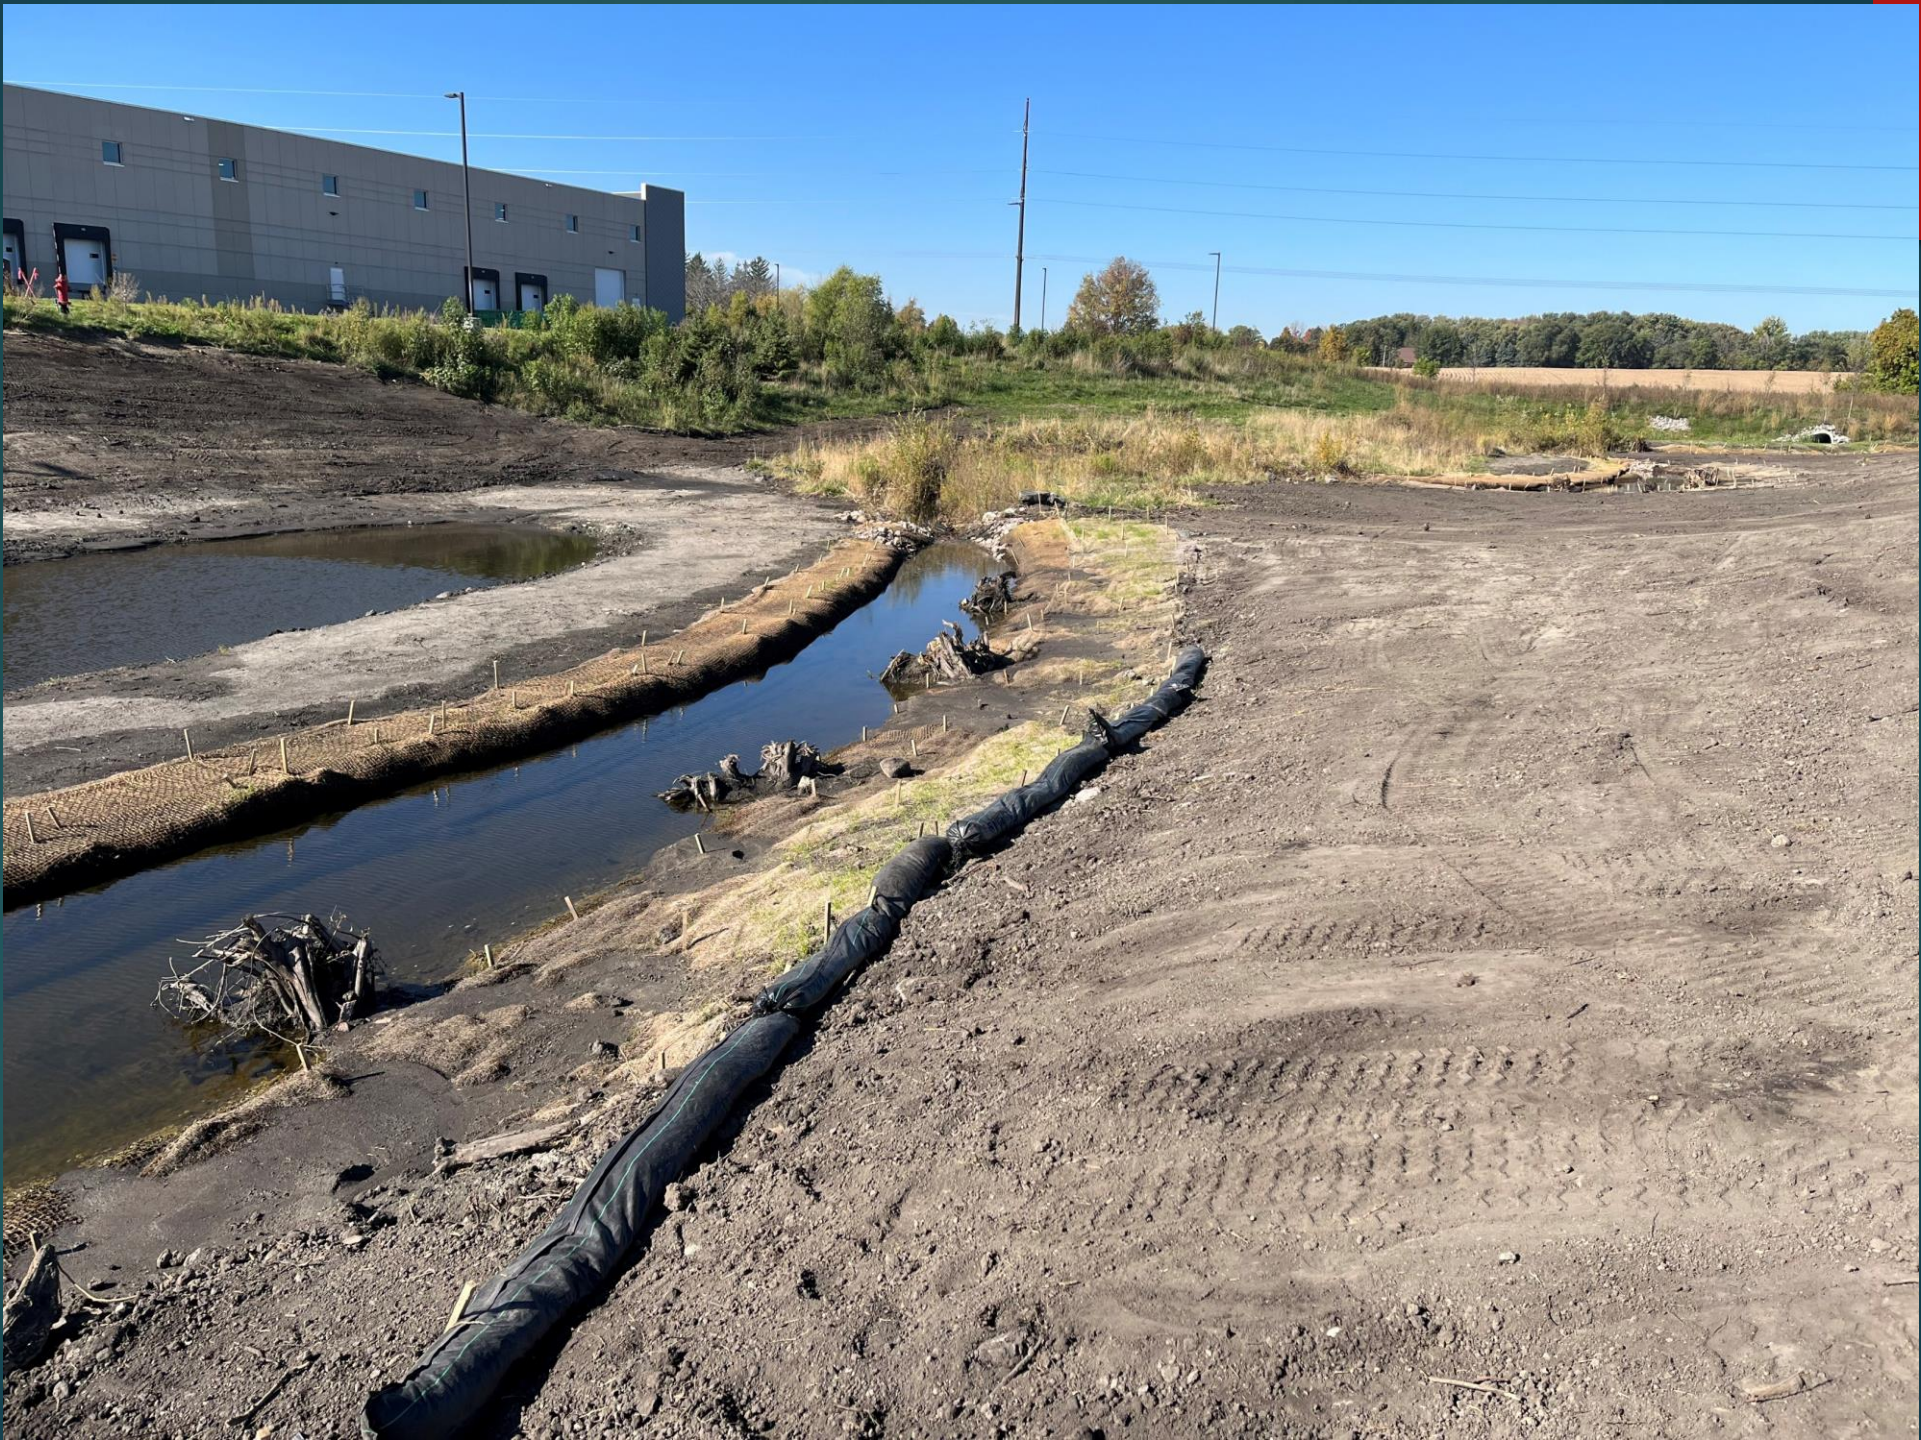
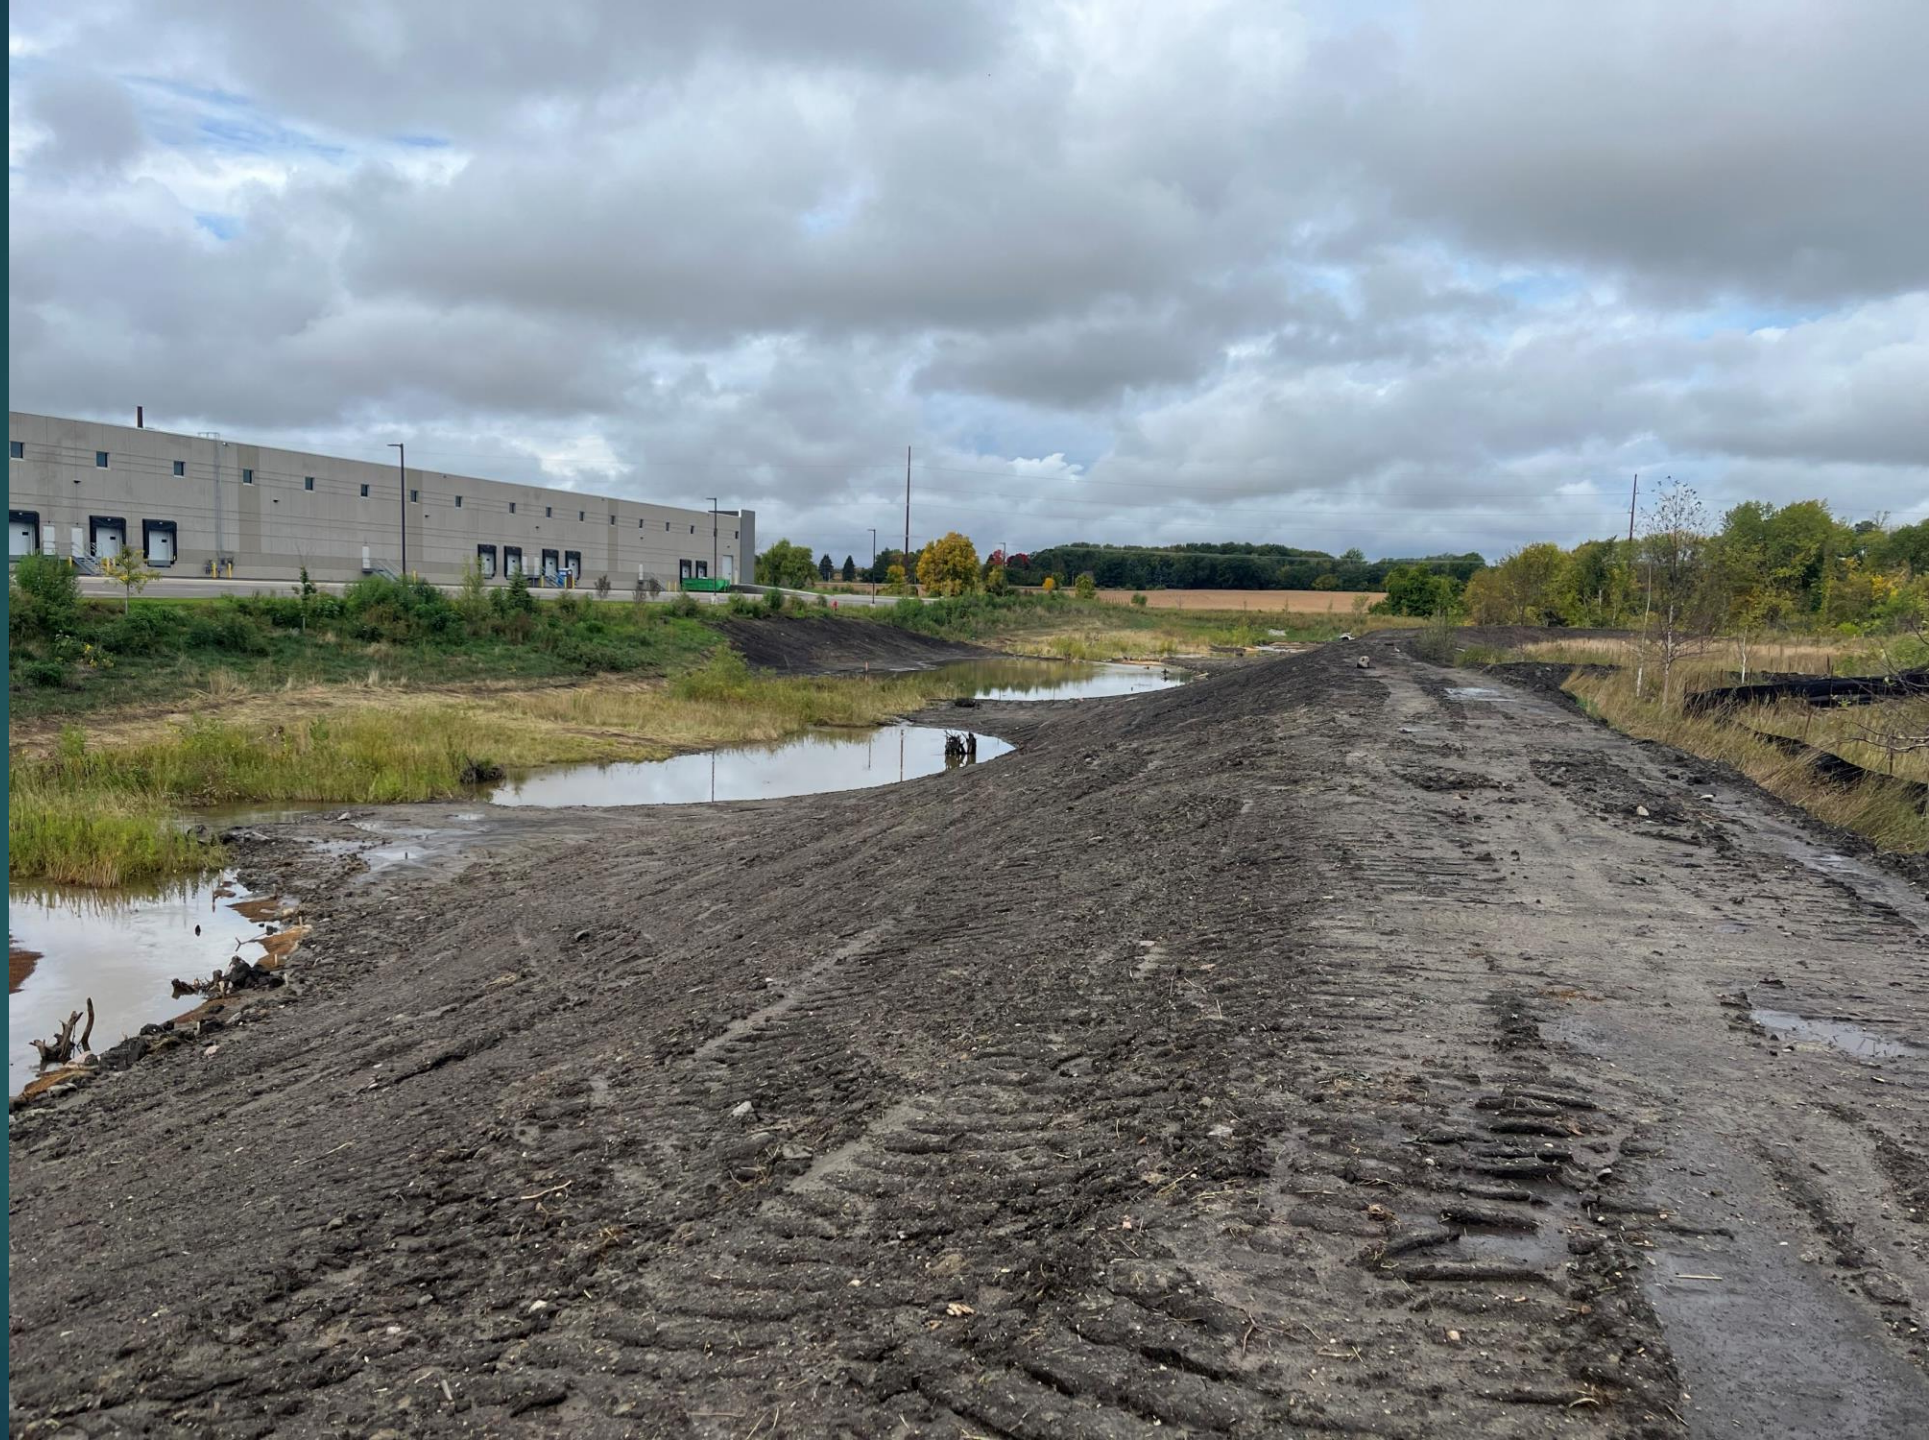
Chaska Creek Remeander Phase 2

- ▶ A 1,000 linear foot ditched section of West Chaska Creek was targeted to add 5 meanders and a floodplain. Phase 1 was the construction of a 100 foot wide floodplain and 5 offline meanders that was completed in 2020. Phase 2 is to finish the floodplain, including the addition of an oxbow pond, and connect the meanders to the main channel.
- ▶ CCWMO received a \$283,000 BWSR Grant and a \$50,000 Lower Minnesota Grant to finish the project. Total costs for Phase 2 are estimated to be \$325,000.

- ▶ Currently in construction, with the plan to be completed by the beginning of October. Past rain events may change that timeline.

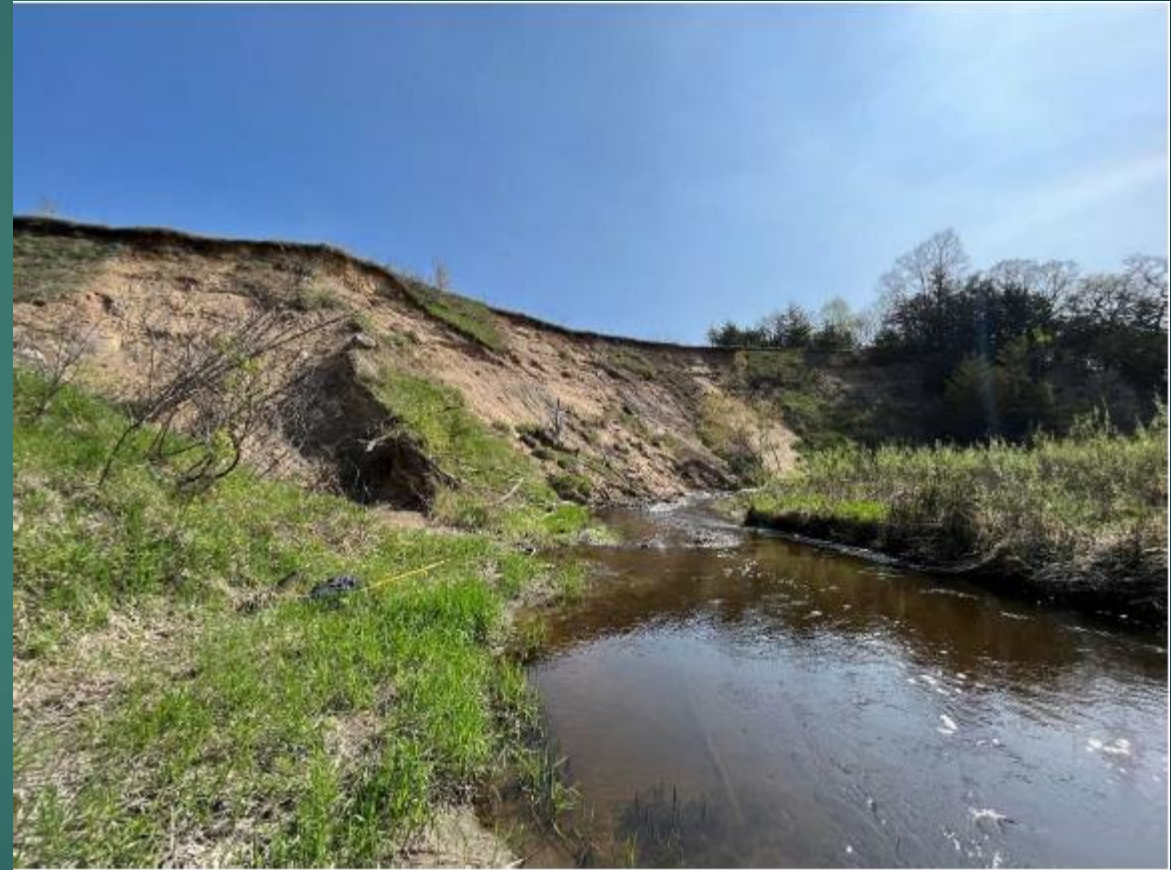
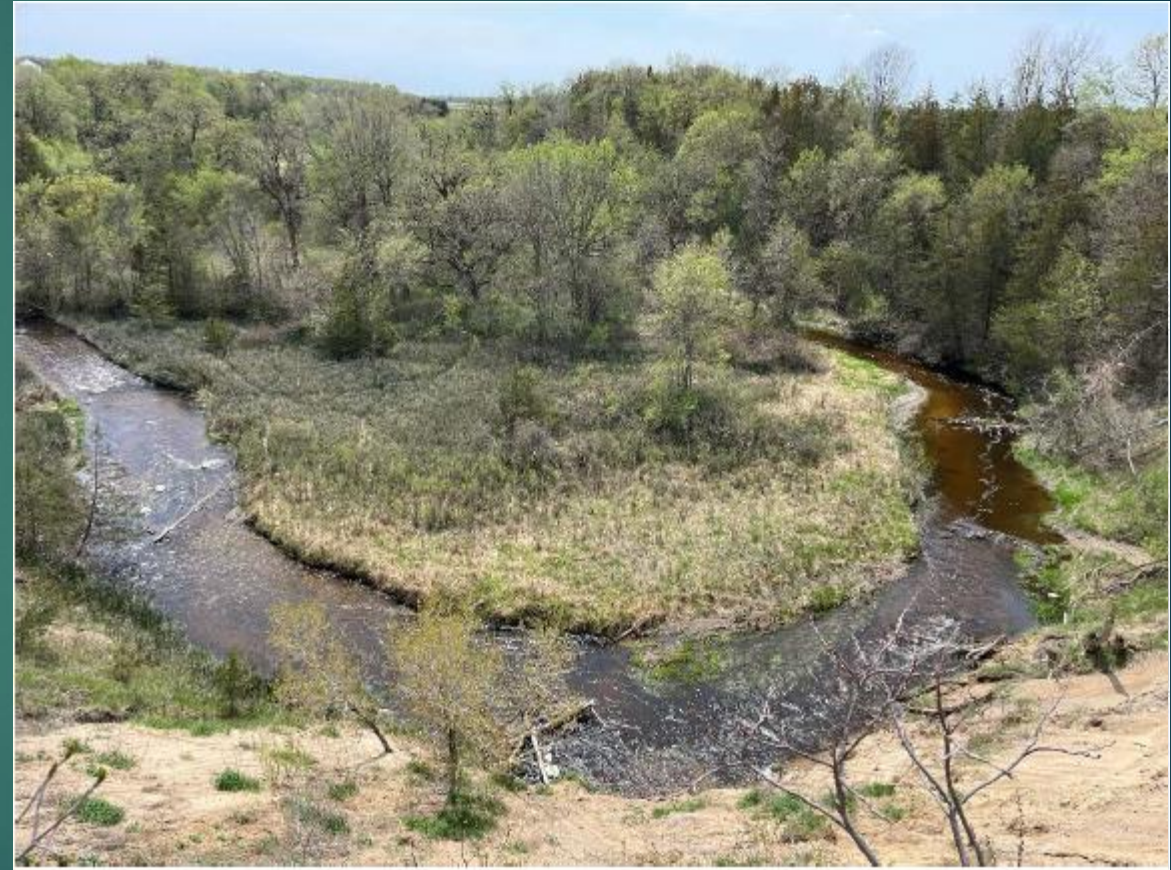
Carver Creek Feasibility Study

- ▶ Background
 - ▶ Site of a large bank failure in 2012
 - ▶ Received \$46,991 in state grants to fund a feasibility study
 - ▶ Contracted with EOR to complete the feasibility study that would include options and costs to address the erosional issues of the site.

- ▶ Update
 - ▶ Received draft study with four options to resolve the erosional issues
 - ▶ Looking to finalize the draft by the end of October with 5 different options.
 - ▶ Currently looking at two options as the best ones moving forward.
 - ▶ Current costs are \$31,332.41.
