Benton Lake Aquatic Vegetation Transplant

Carver County Water Management Organization

9/24/2024

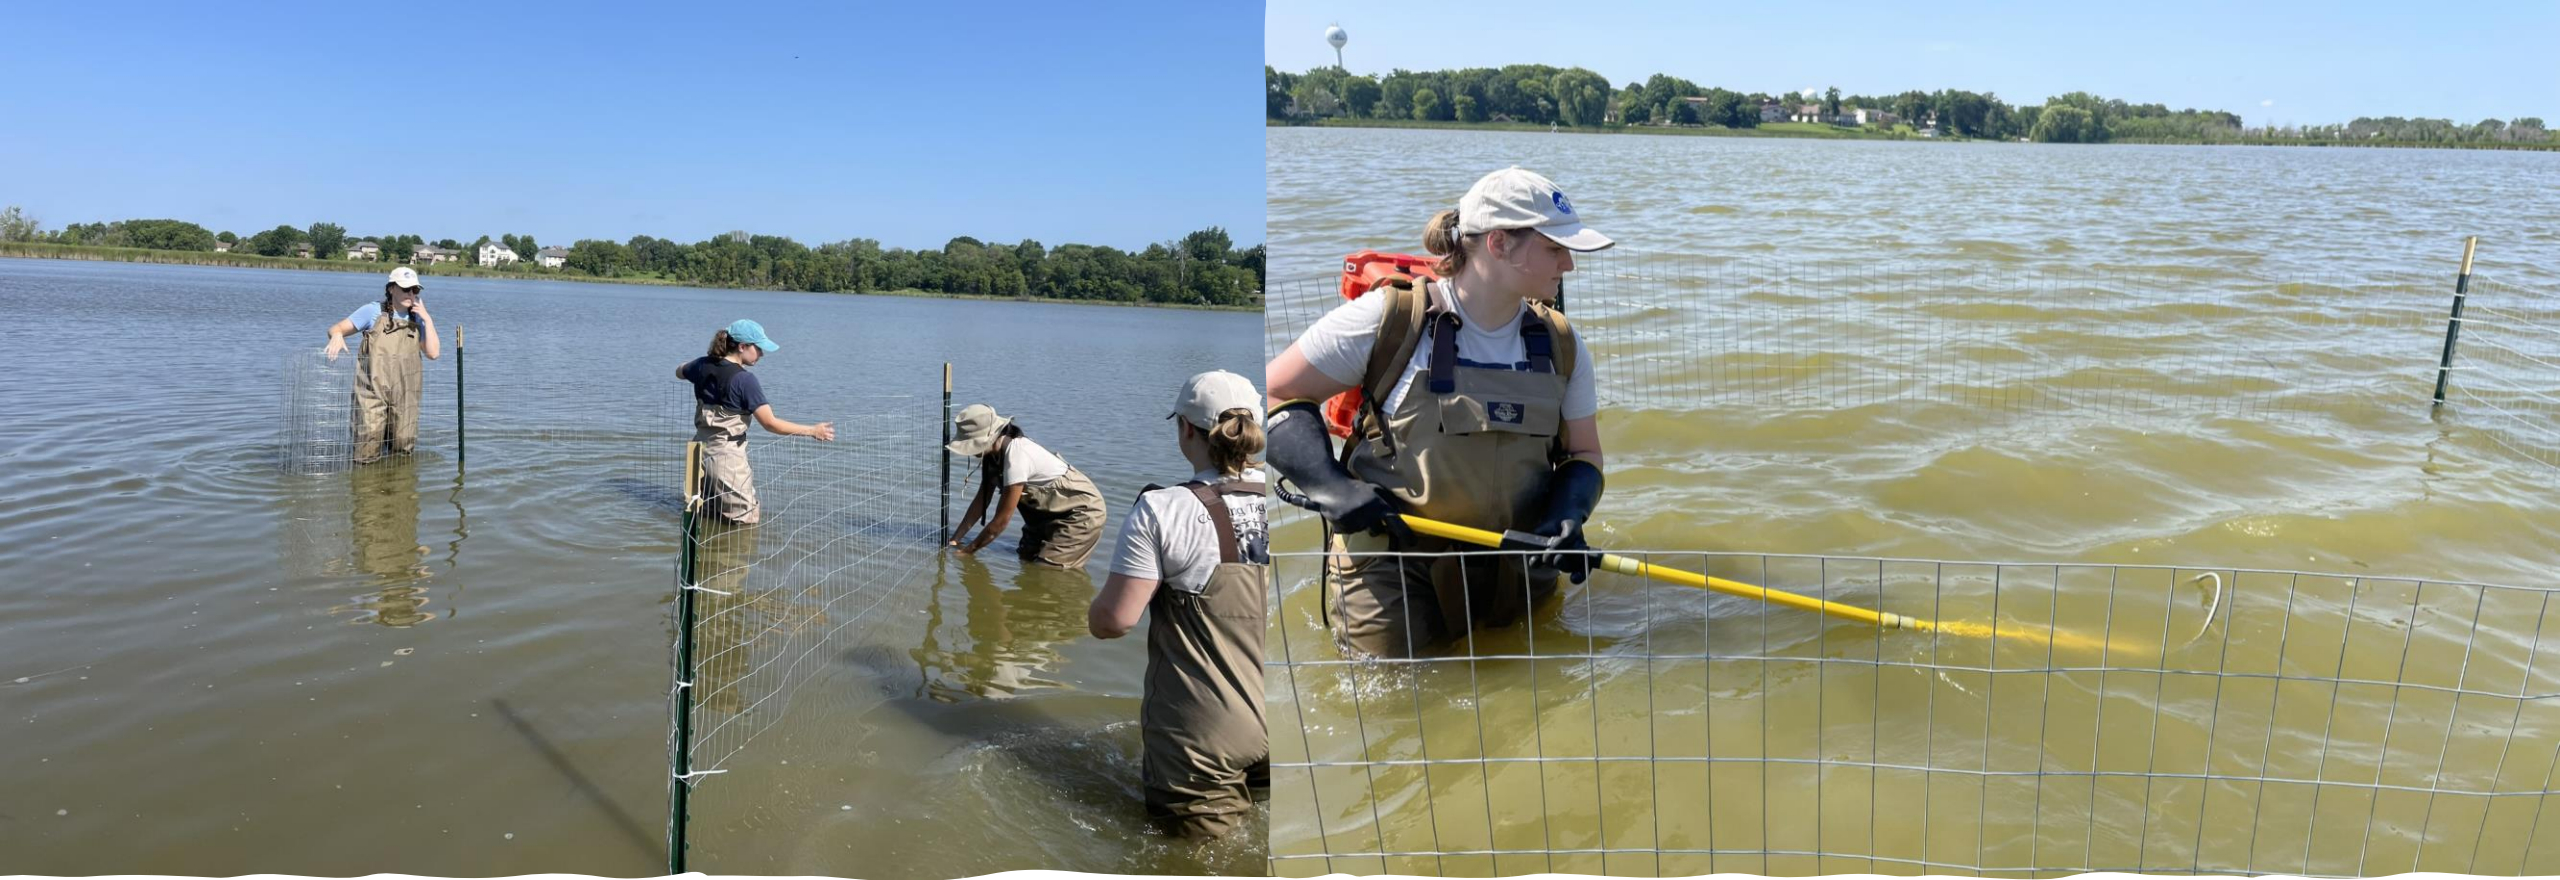
2024 Pre-Transplant Aquatic Vegetation Survey

26% of sites sampled had sago pondweed

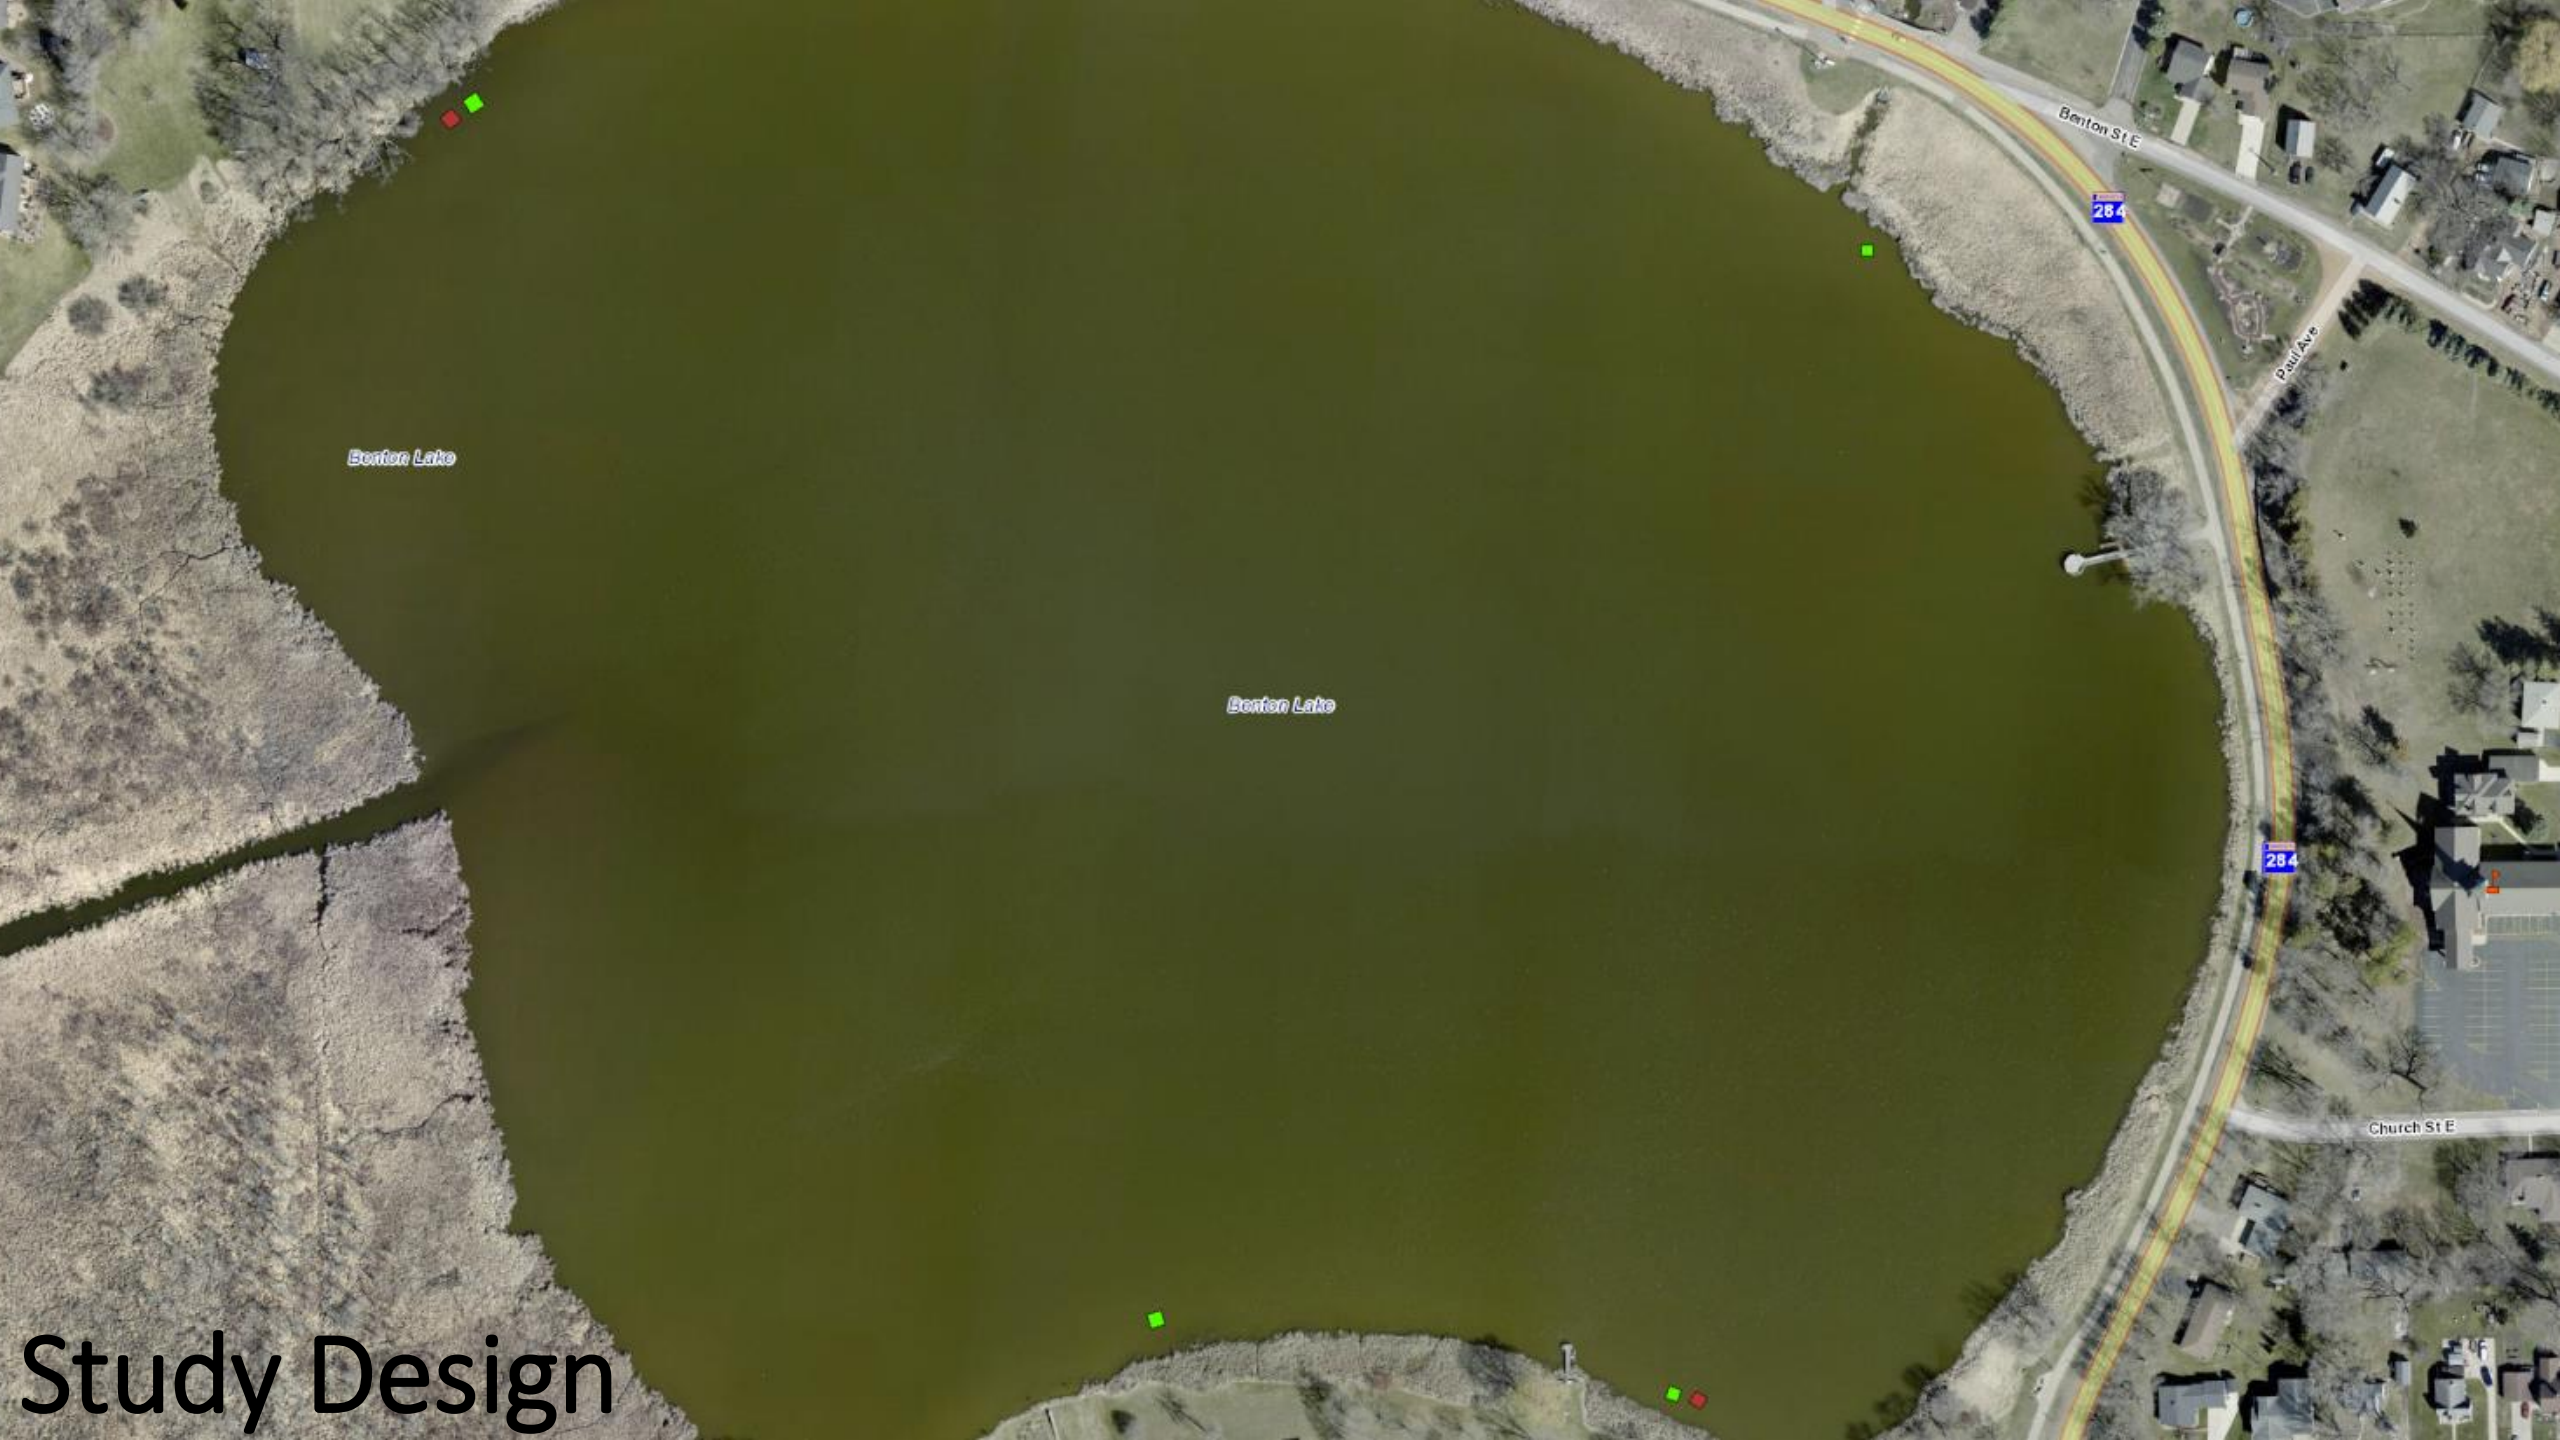
- Install exclusion pens
 - Partnered with the Benton Lake Conservancy to purchase materials

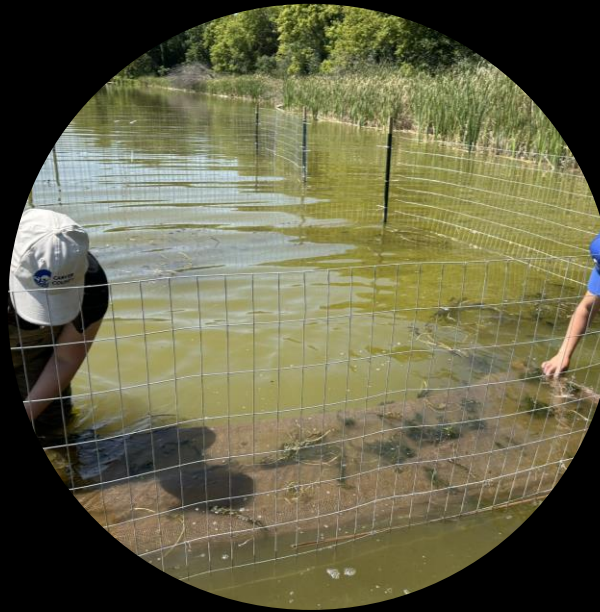
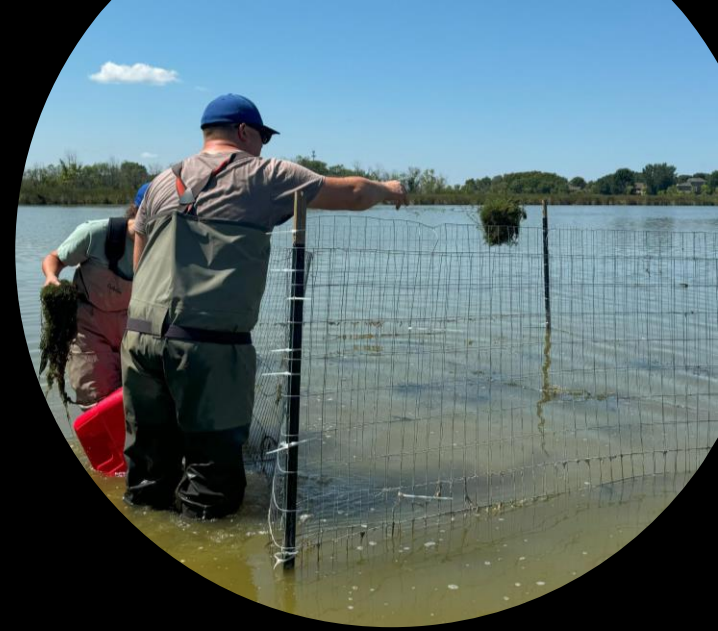
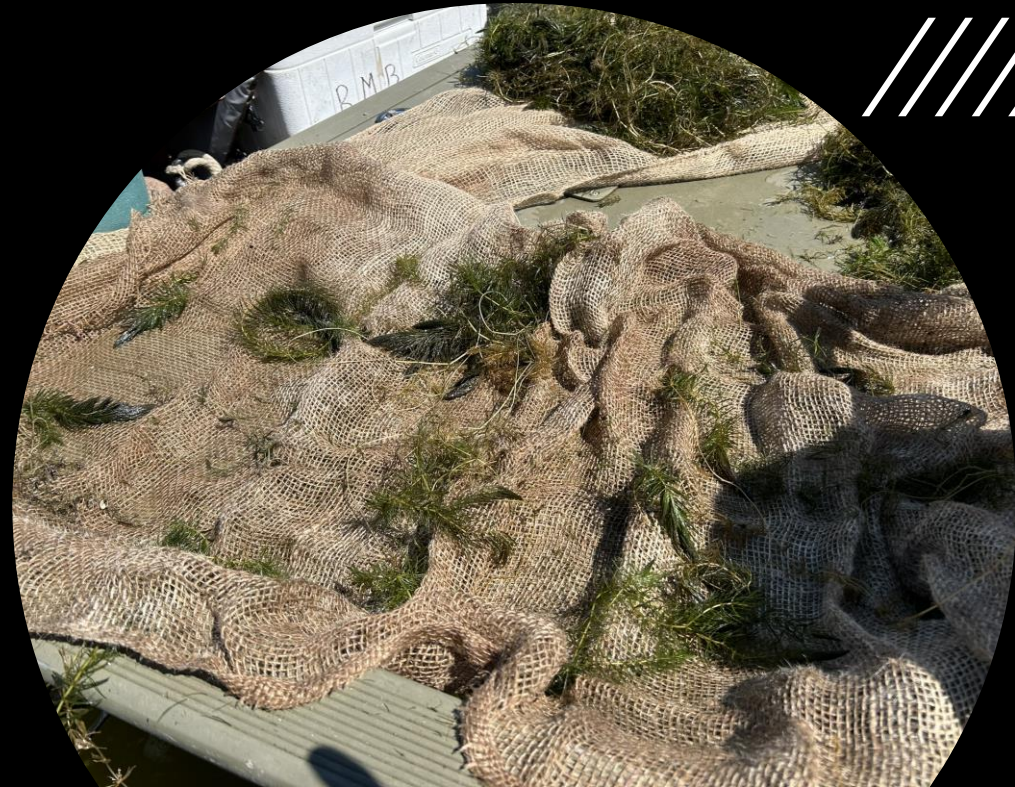
- Installation
 - Two Methods
 - Threaded plants through burlap
 - Cooler dump

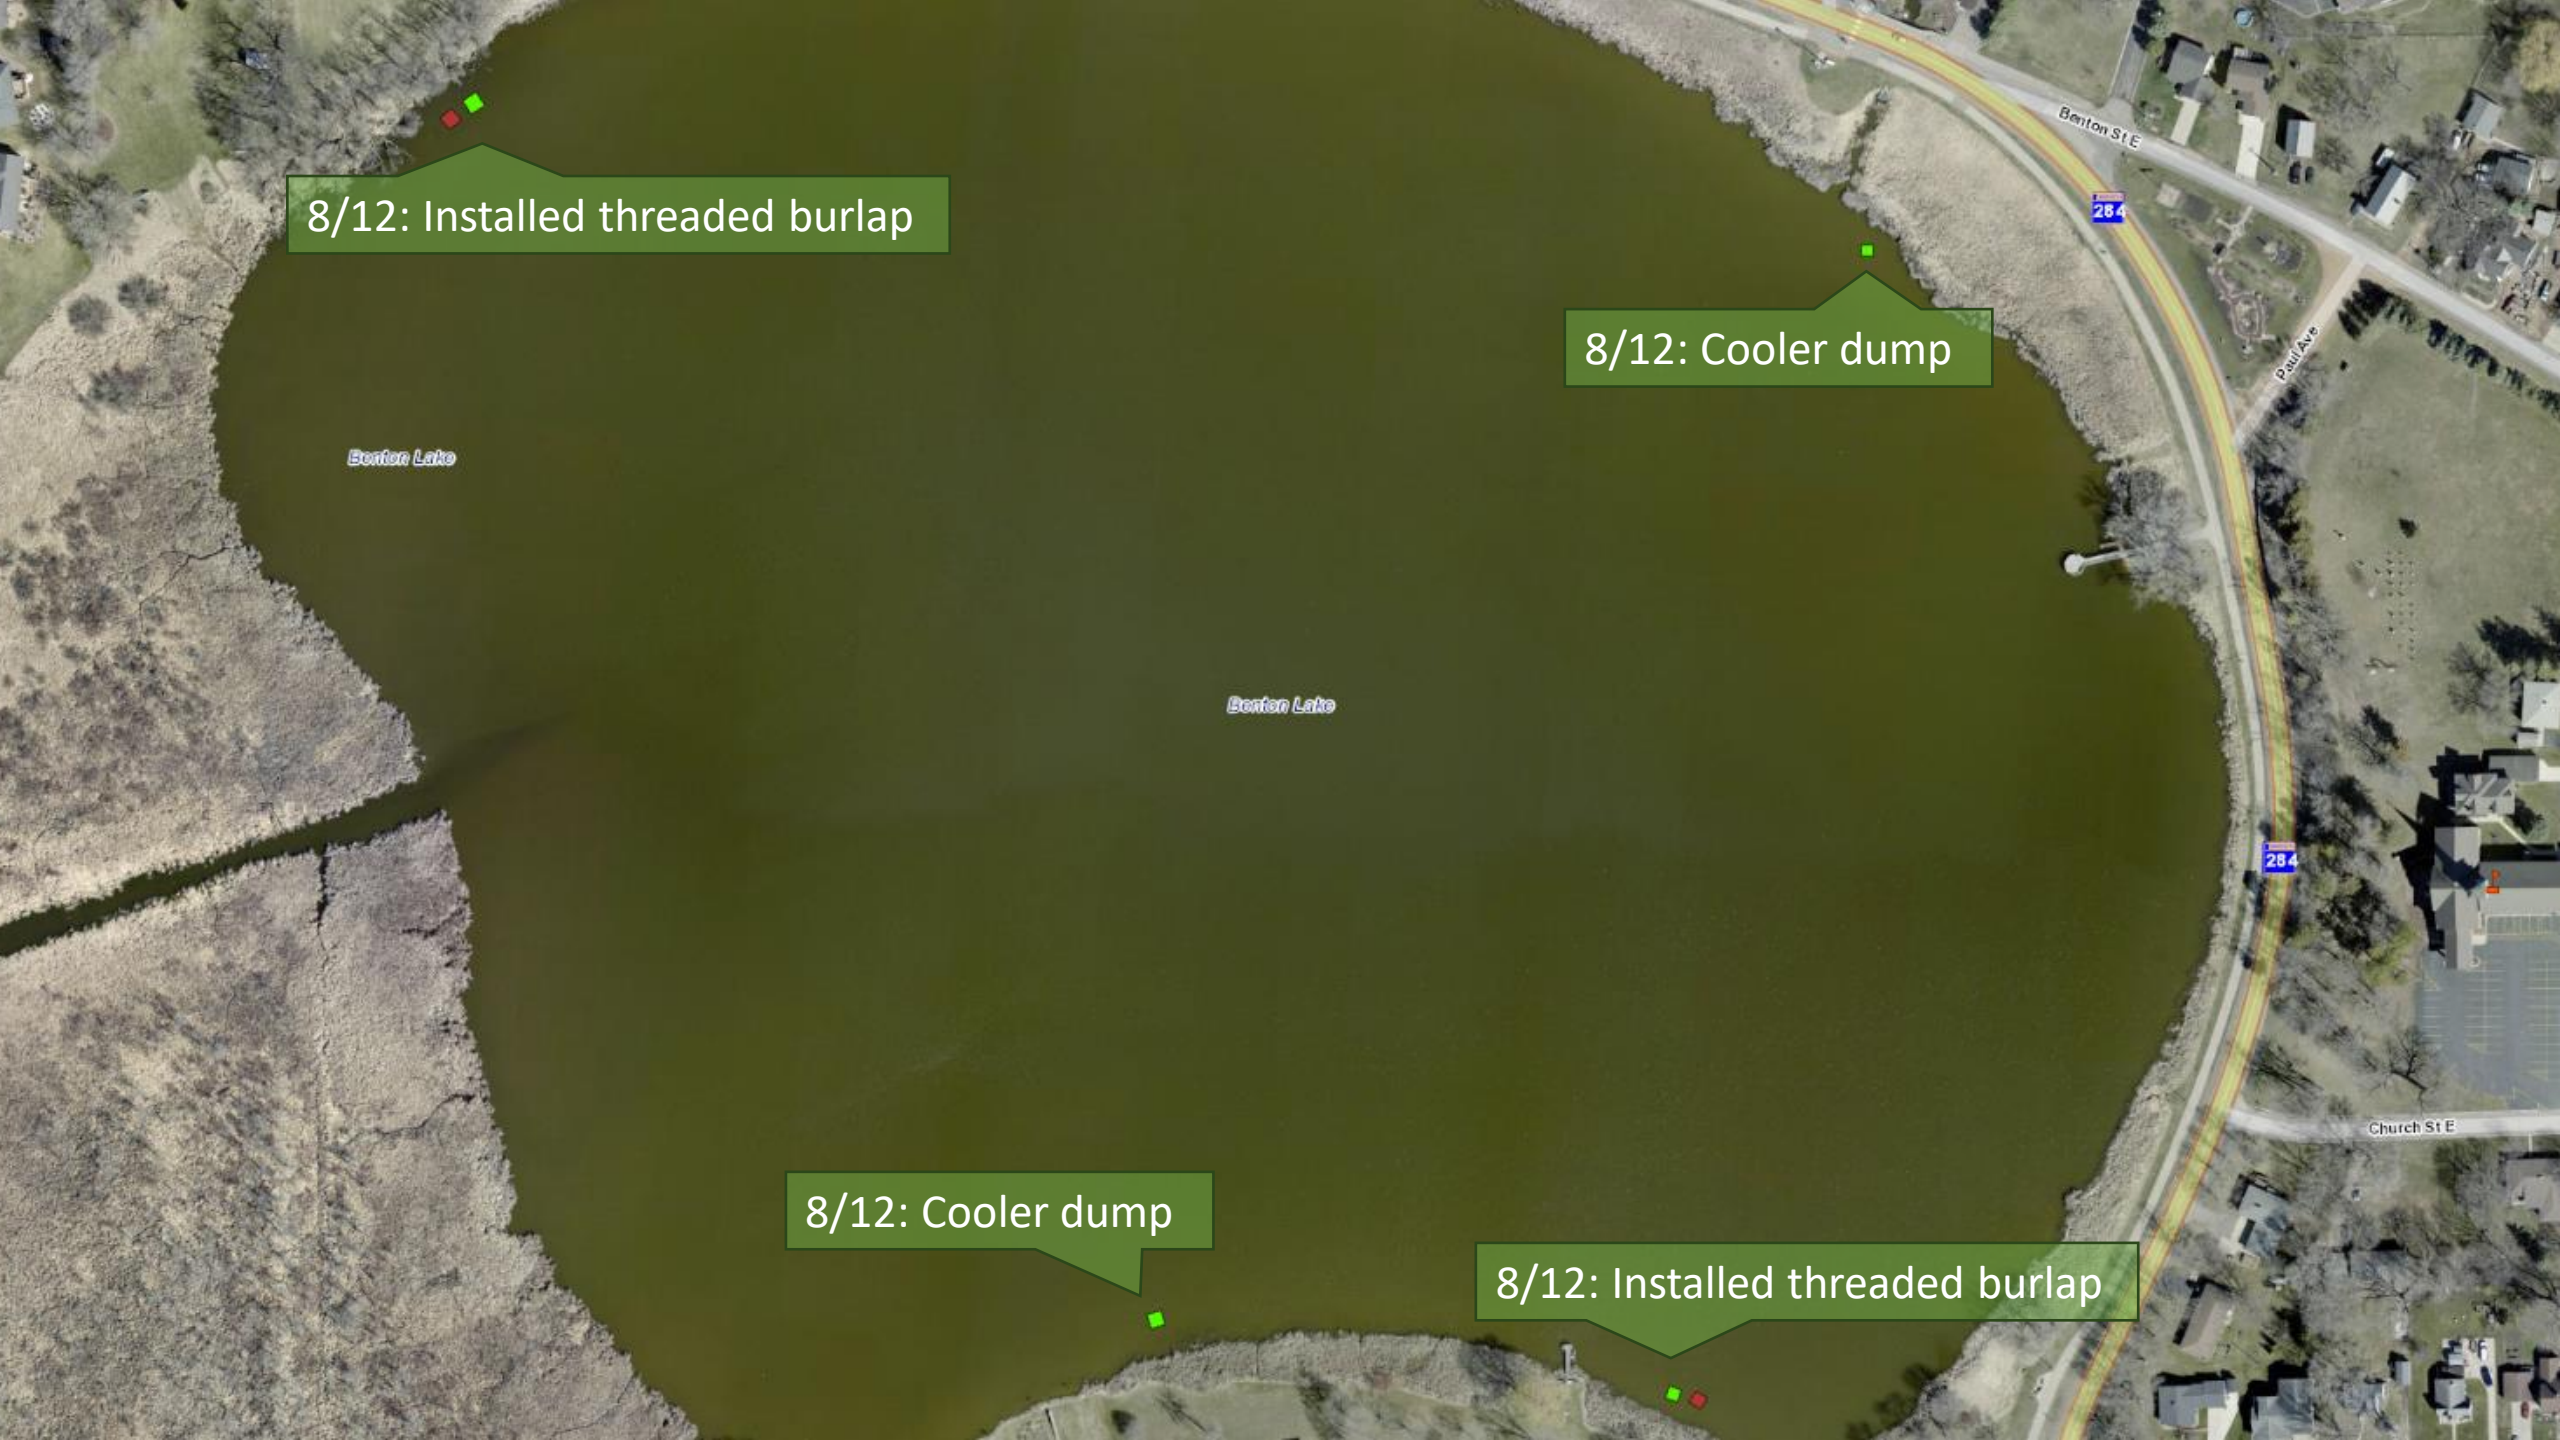
8/12: Installed threaded burlap

8/12: Cooler dump

9/9: No action taken

9/9: Installed threaded burlap
