FINAL MEMORANDUM

SUBJECT: CARVER COUNTY NON-MOTORIZED FACILITIES INVENTORY

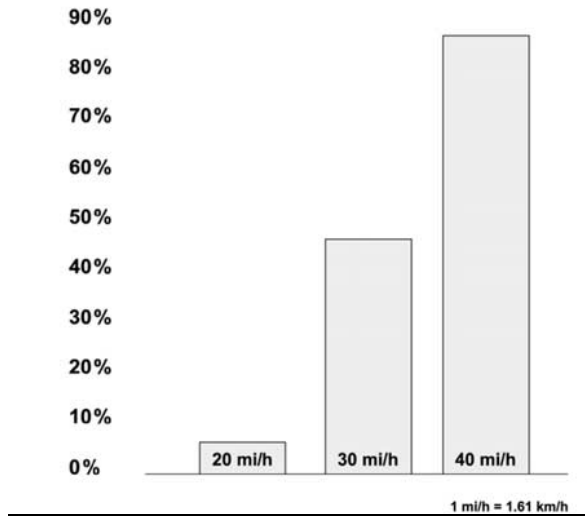
Figure 1

A pedestrian's chance of death if hit by a motor vehicle:

Fatalities Based on Vehicle Speed

- 2. Posted Speed Limit \geq 40 mph:** Speed is a major factor in all types of crashes, and can be particularly fatal in pedestrian and bicycle crashes. As shown in Figure 1, a pedestrian hit at 40 mph has an 85 percent chance of being killed, as opposed to a pedestrian hit at 20 mph, who has a five percent chance of being killed. This is mainly due to motorists having less reaction at higher speeds and the vulnerability of pedestrians and bicyclists traveling along or crossing roadway facilities. A posted speed limit \geq 40 mph was identified as an issue if more than 50 percent of the segment has a posted speed limit above the threshold.

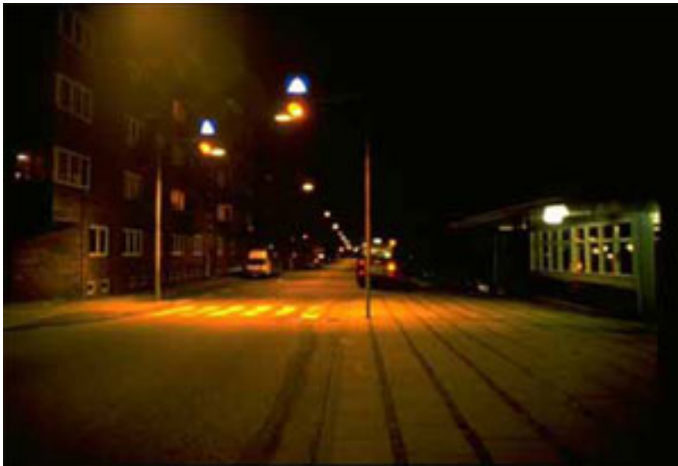
Figure 2

Crosswalk Lighting

- 3. Lighting at Major Intersections:** The visibility of pedestrians and bicyclists is based on a number of factors, including: screening by physical objects; lack of lighting, and roadway geometry. Providing lighting for pedestrians is a proven safety strategy for vehicles, pedestrians and bicyclists during day and nighttime conditions. Major intersections without current lighting were identified as a potential safety issue.

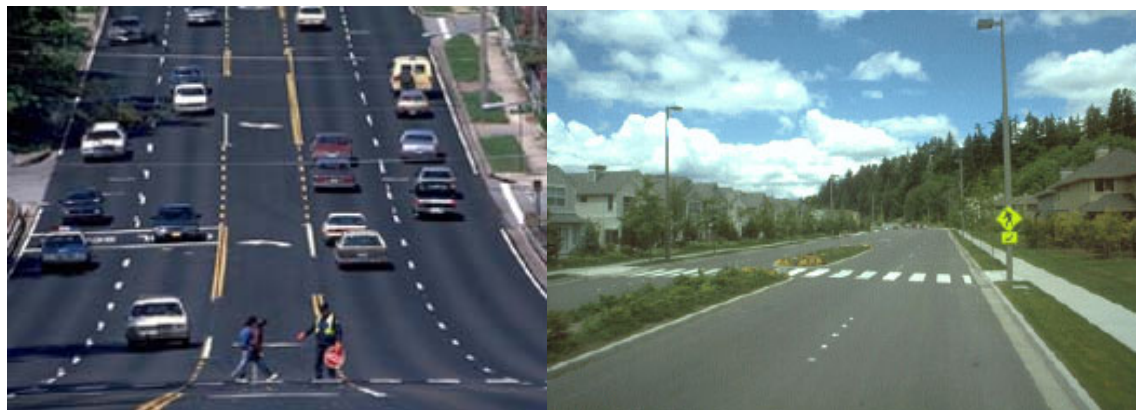
Figure 3
Multi-Lane Crossing Examples

- 4. Three or Four-Lane Undivided Roadway:** The number of lanes that pedestrians and bicyclists need to cross significantly affects their safety. Studies have shown that the number of roadway lanes (three or more lanes vs. two lanes) are directly related to crash rates. In particular, multi-lane roads with raised medians provided significantly lower pedestrian crash rates, compared to similar roads with no raised median. Roadways that have more than two lanes of travel, and do not provide a raised center pedestrian refuge area, were identified as a safety issue.
